RECREATIONAL FACILITIES INVENTORY

TOWN OF BELMONT | JUNE 30, 2022

ACTIVITAS
landscape architecture | civil engineering

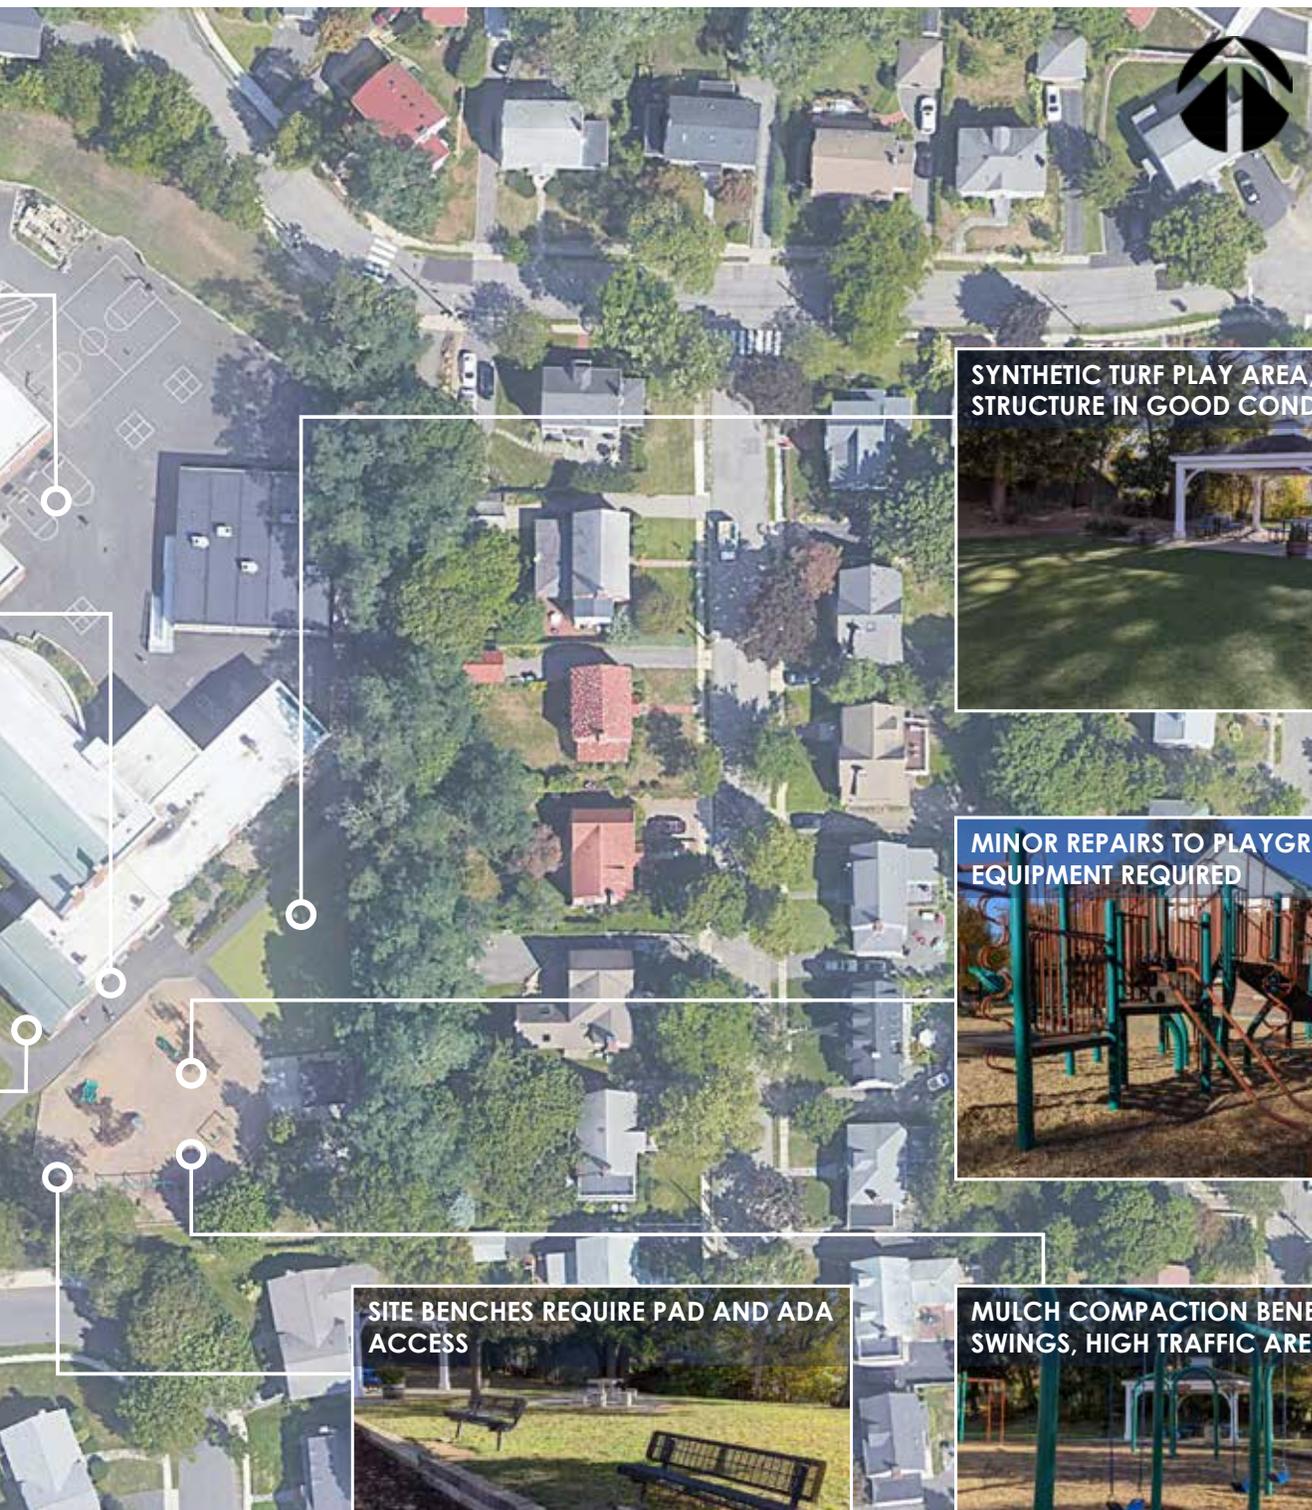
SYNTHETIC TURF PLAY AREA, SHADE STRUCTURE IN GOOD CONDITION

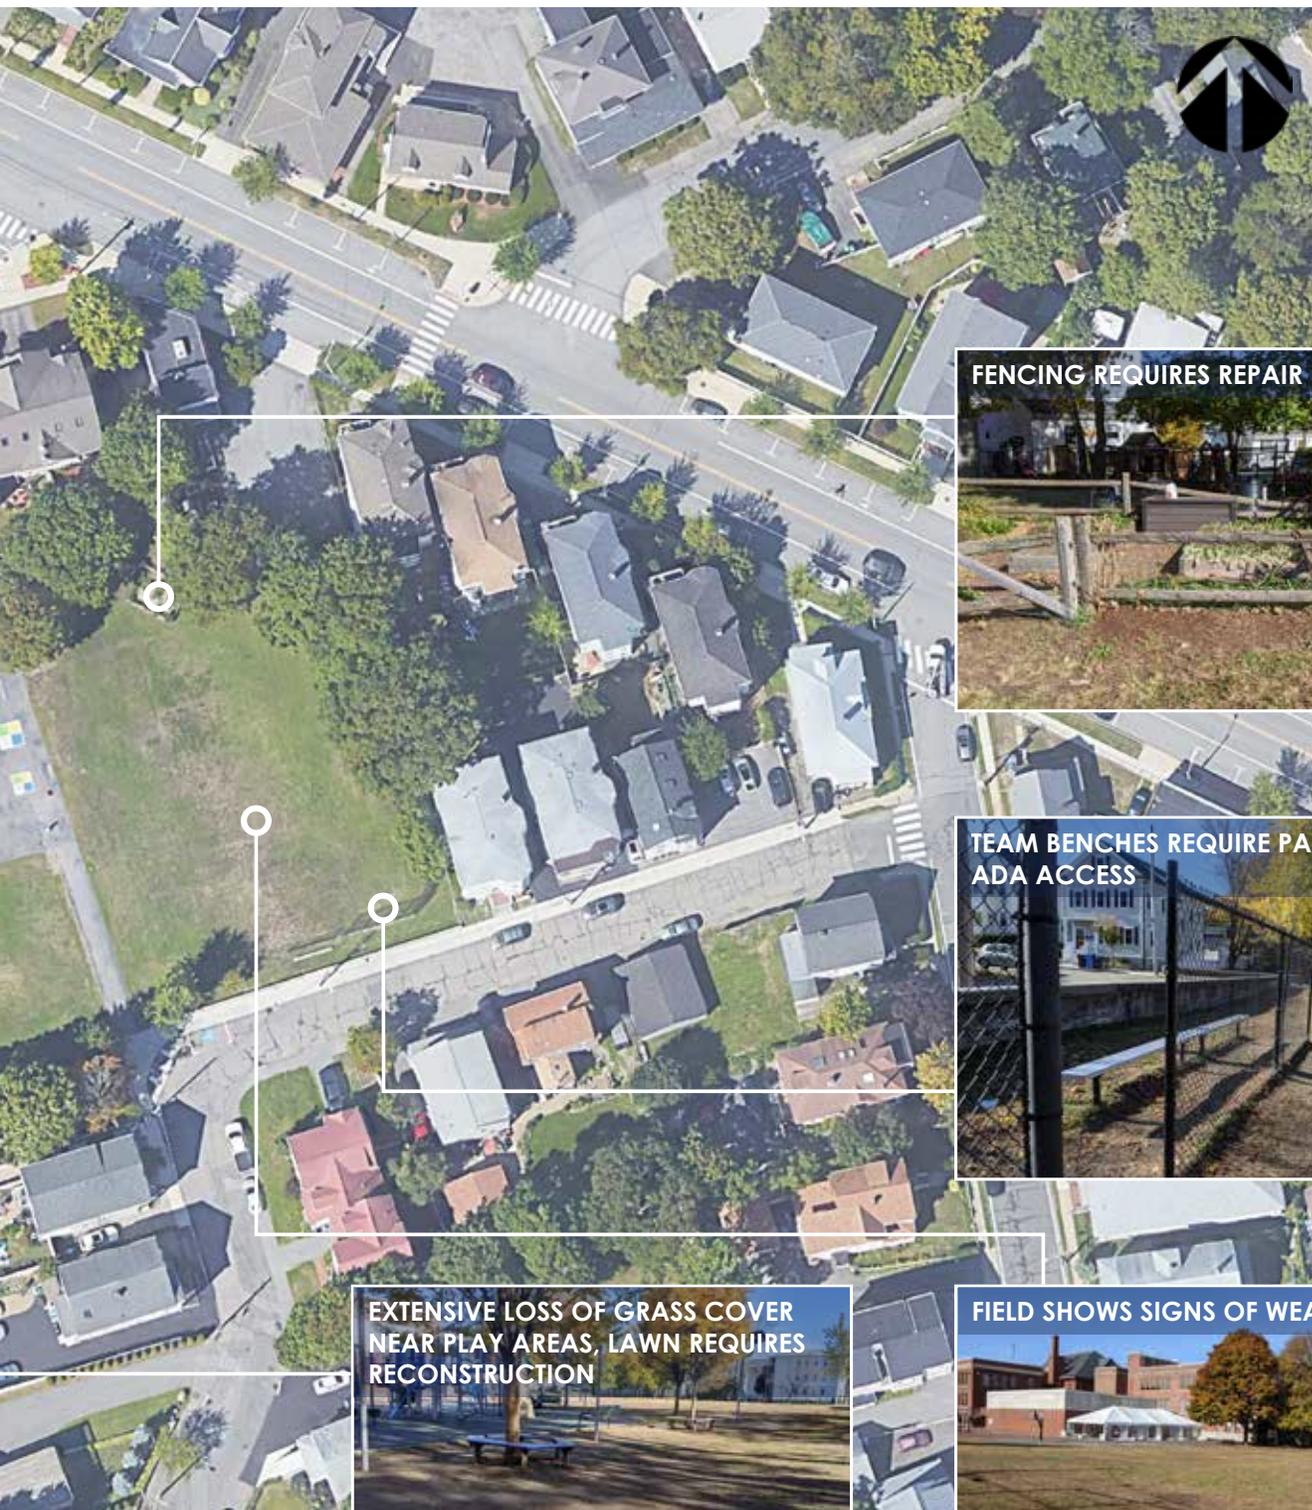
FENCING REQUIRES REPAIR

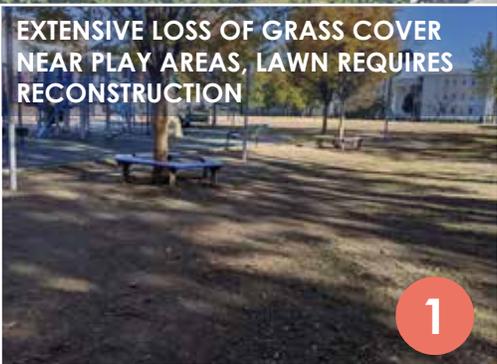
EXTENSIVE LOSS OF GRASS COVER NEAR PLAY AREAS, LAWN REQUIRES RECONSTRUCTION

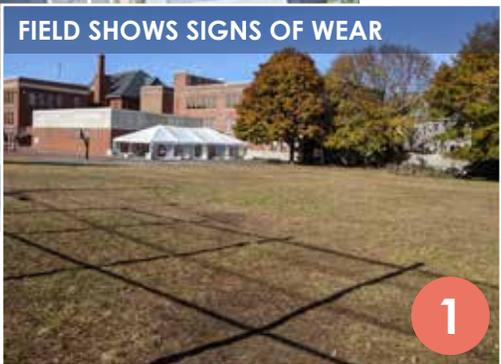
FIELD SHOWS SIGNS OF WEAR

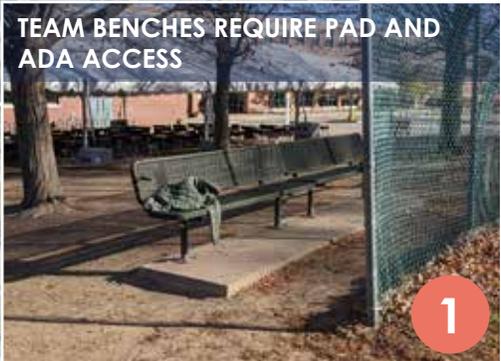
TEAM BENCHES REQUIRE PAD AND ADA ACCESS

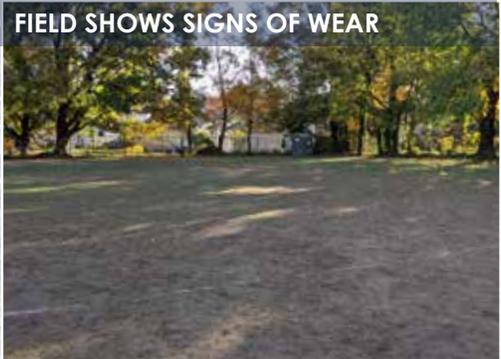
FIELD SHOWS SIGNS OF WEAR

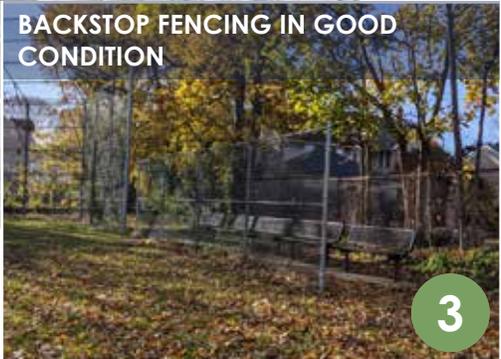
BACKSTOP FENCING IN GOOD CONDITION

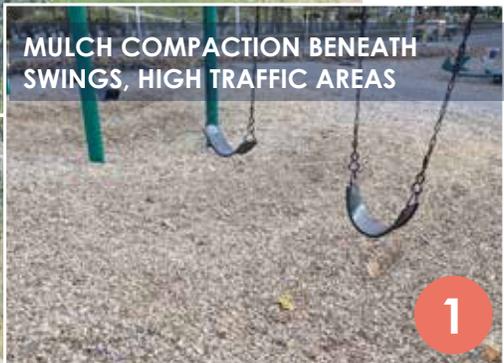
MULCH COMPACTION BENEATH SWINGS, HIGH TRAFFIC AREAS

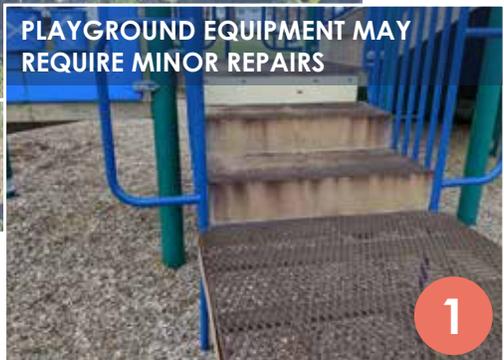
PLAYGROUND EQUIPMENT MAY REQUIRE MINOR REPAIRS

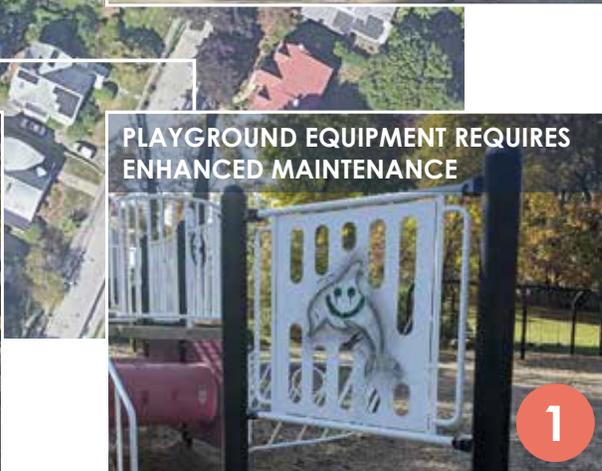
PLAYGROUND EQUIPMENT MAY REQUIRE MINOR REPAIRS

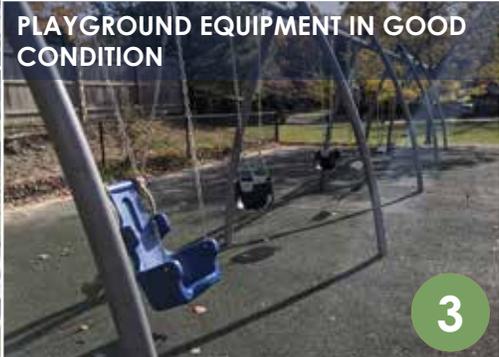
PLAYGROUND EQUIPMENT IN GOOD CONDITION

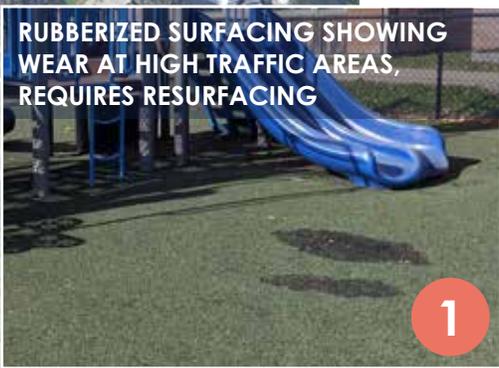
RUBBERIZED SURFACING SHOWING WEAR AT HIGH TRAFFIC AREAS, REQUIRES RESURFACING

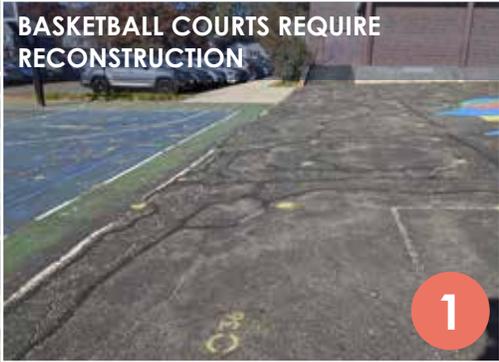
BASKETBALL COURTS REQUIRE RECONSTRUCTION

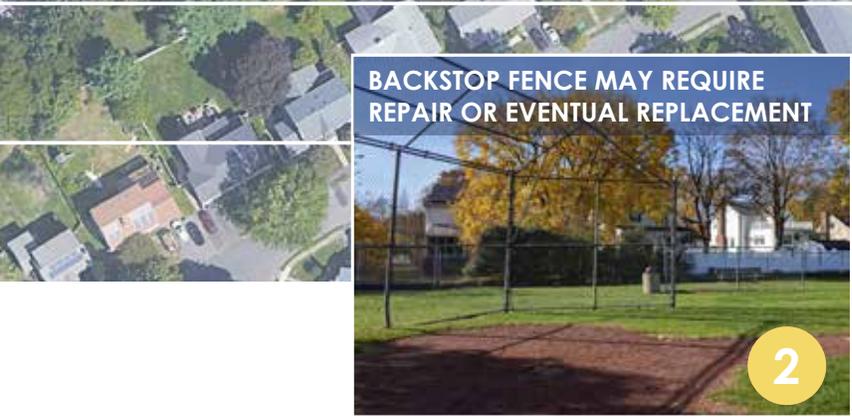
BACKSTOP FENCE MAY REQUIRE REPAIR OR EVENTUAL REPLACEMENT

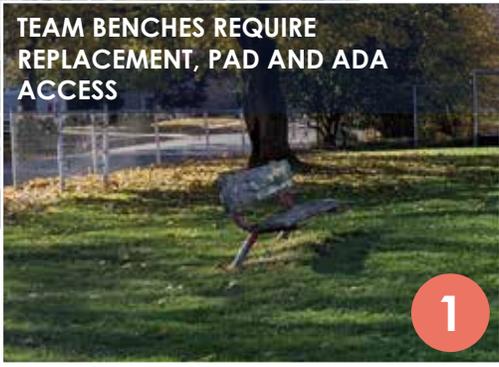
TEAM BENCHES REQUIRE REPLACEMENT, PAD AND ADA ACCESS
