RECREATIONAL FACILITIES INVENTORY

2024 UPDATE

TOWN OF BELMONT | OCTOBER 11, 2024

In the fall of 2021, Activitas, Inc. was retained by the Town of Belmont to perform a comprehensive inventory, conditions review and usage analysis of the following town-owned parks:

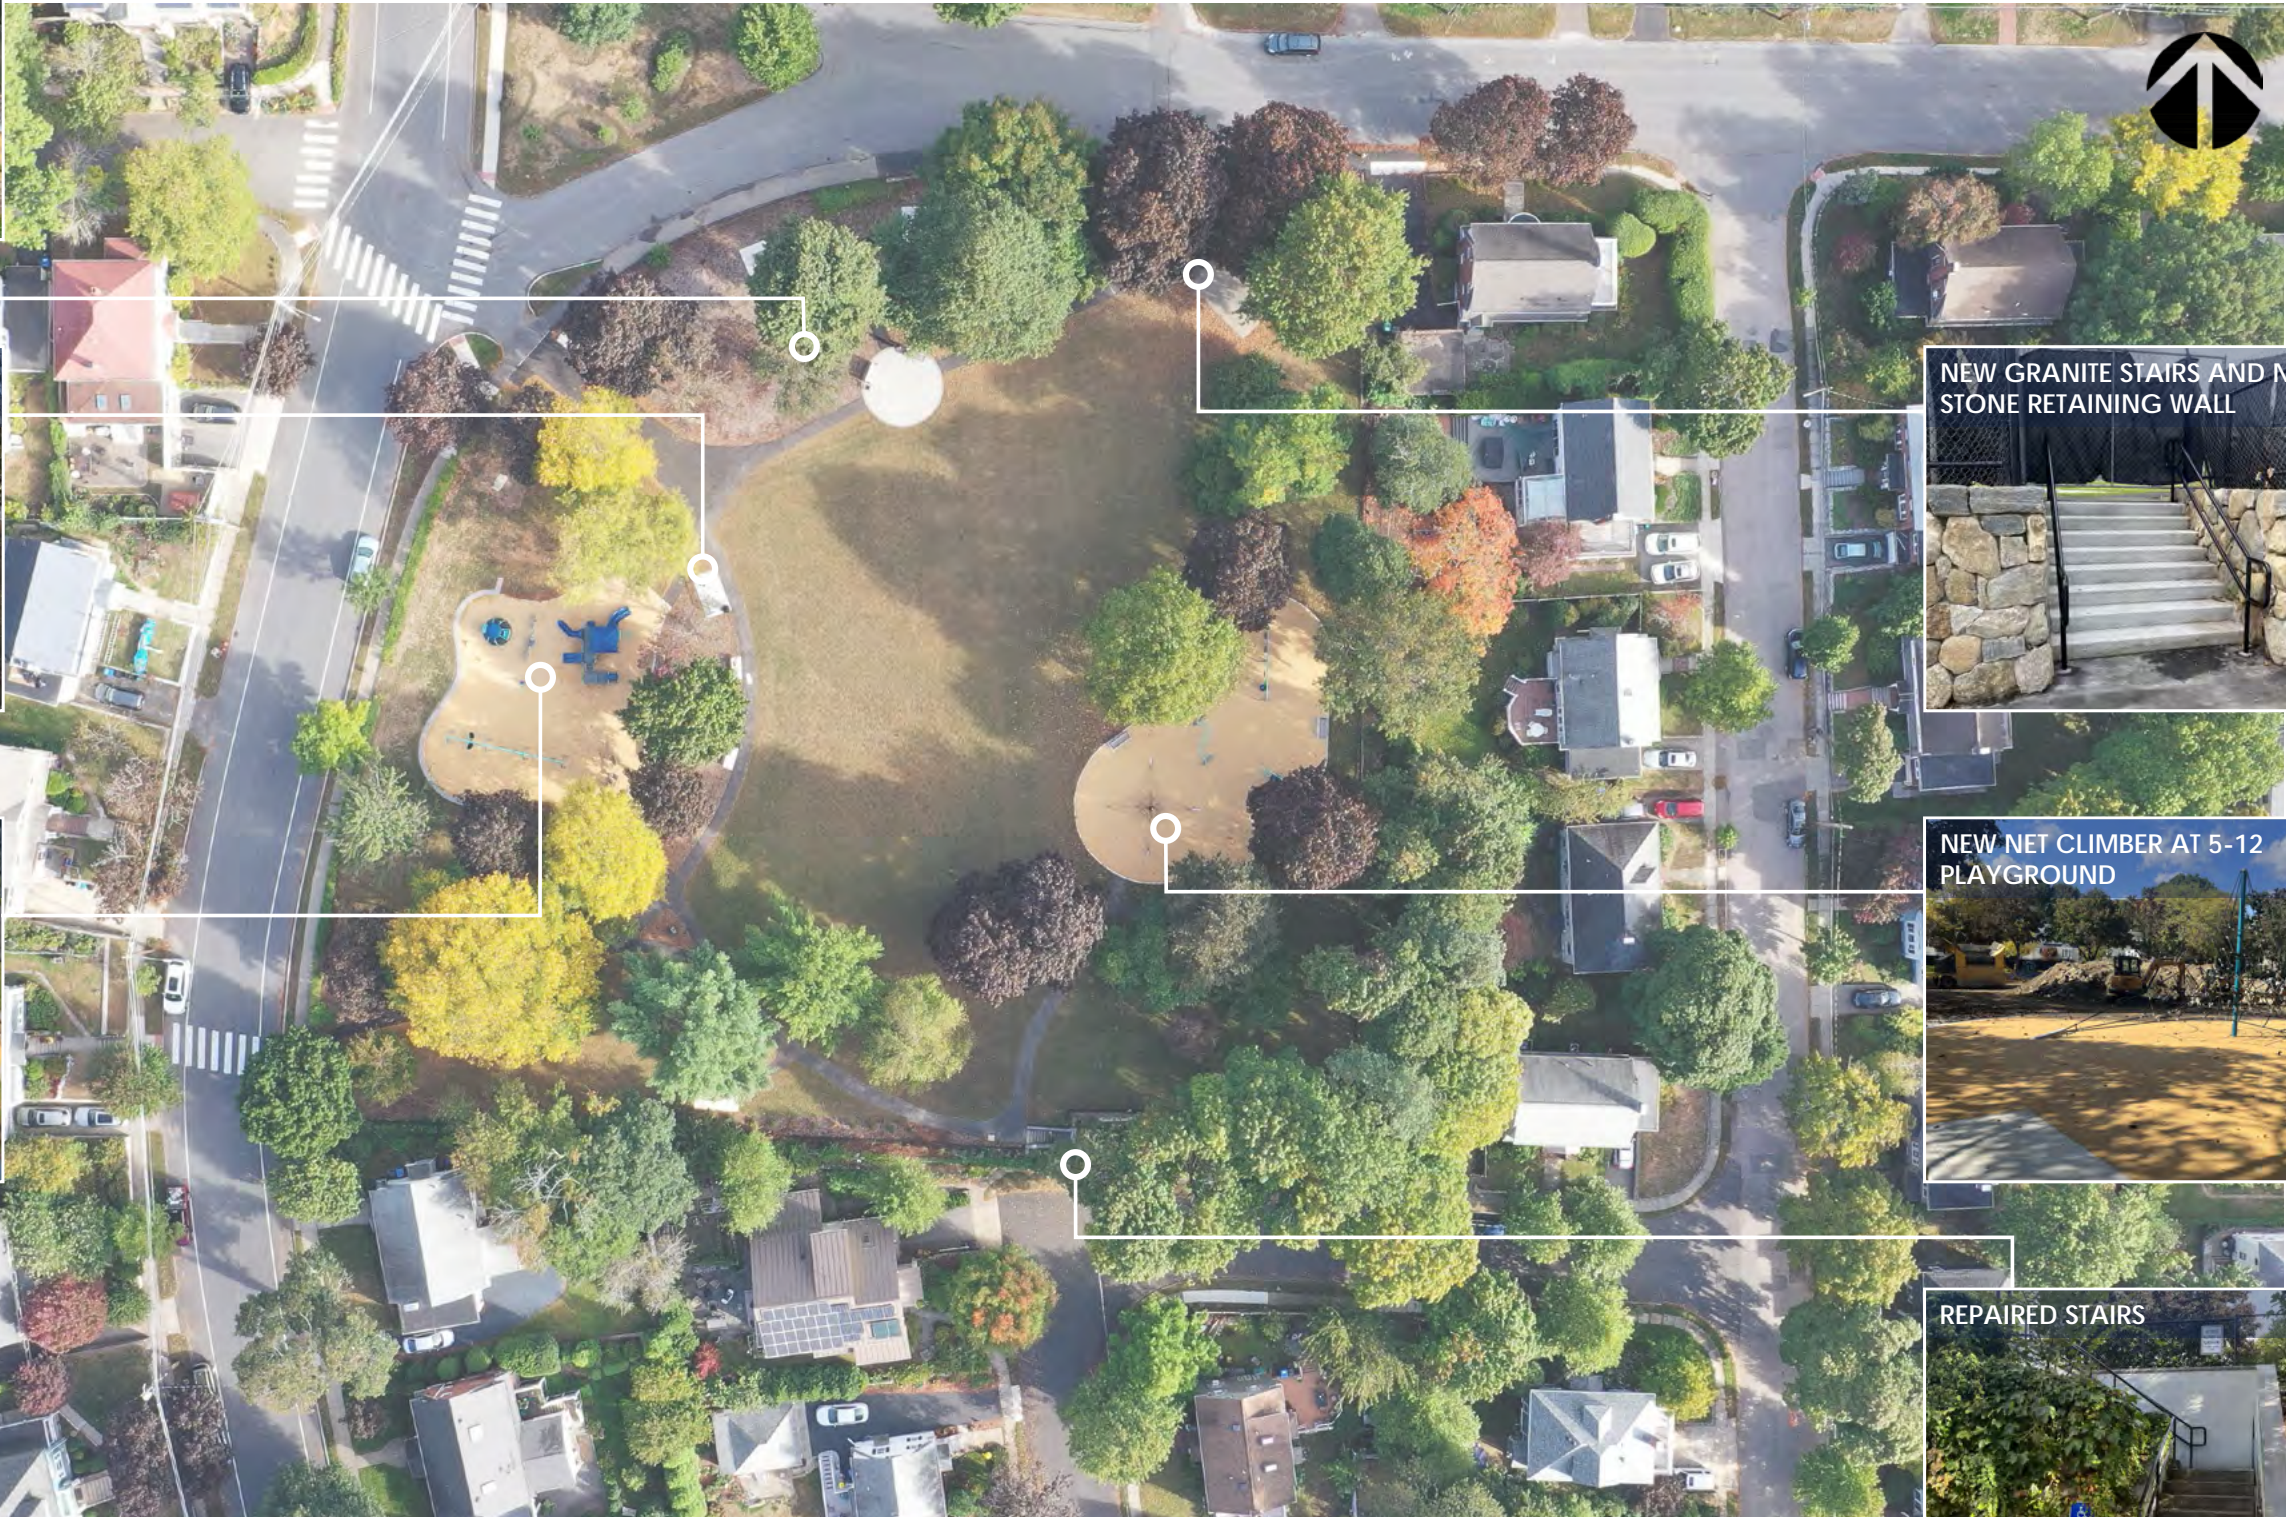
Payson Park was entirely renovated in 2023. Both playgrounds have been rebuilt with equipment from Landscape Structures, Inc. and accessible poured-in-place play surfacing. New ADA picnic tables were purchased and mounted on concrete pads. The entire field area was regraded with imported loam and seeded. The concrete stage remains in place with new electric service. Accessible paved routes have now been provided to all areas. Both stairways have also been renovated with new handrails, and signage at those entrances direct visitors to the ADA-accessible entrances on Payson Road.

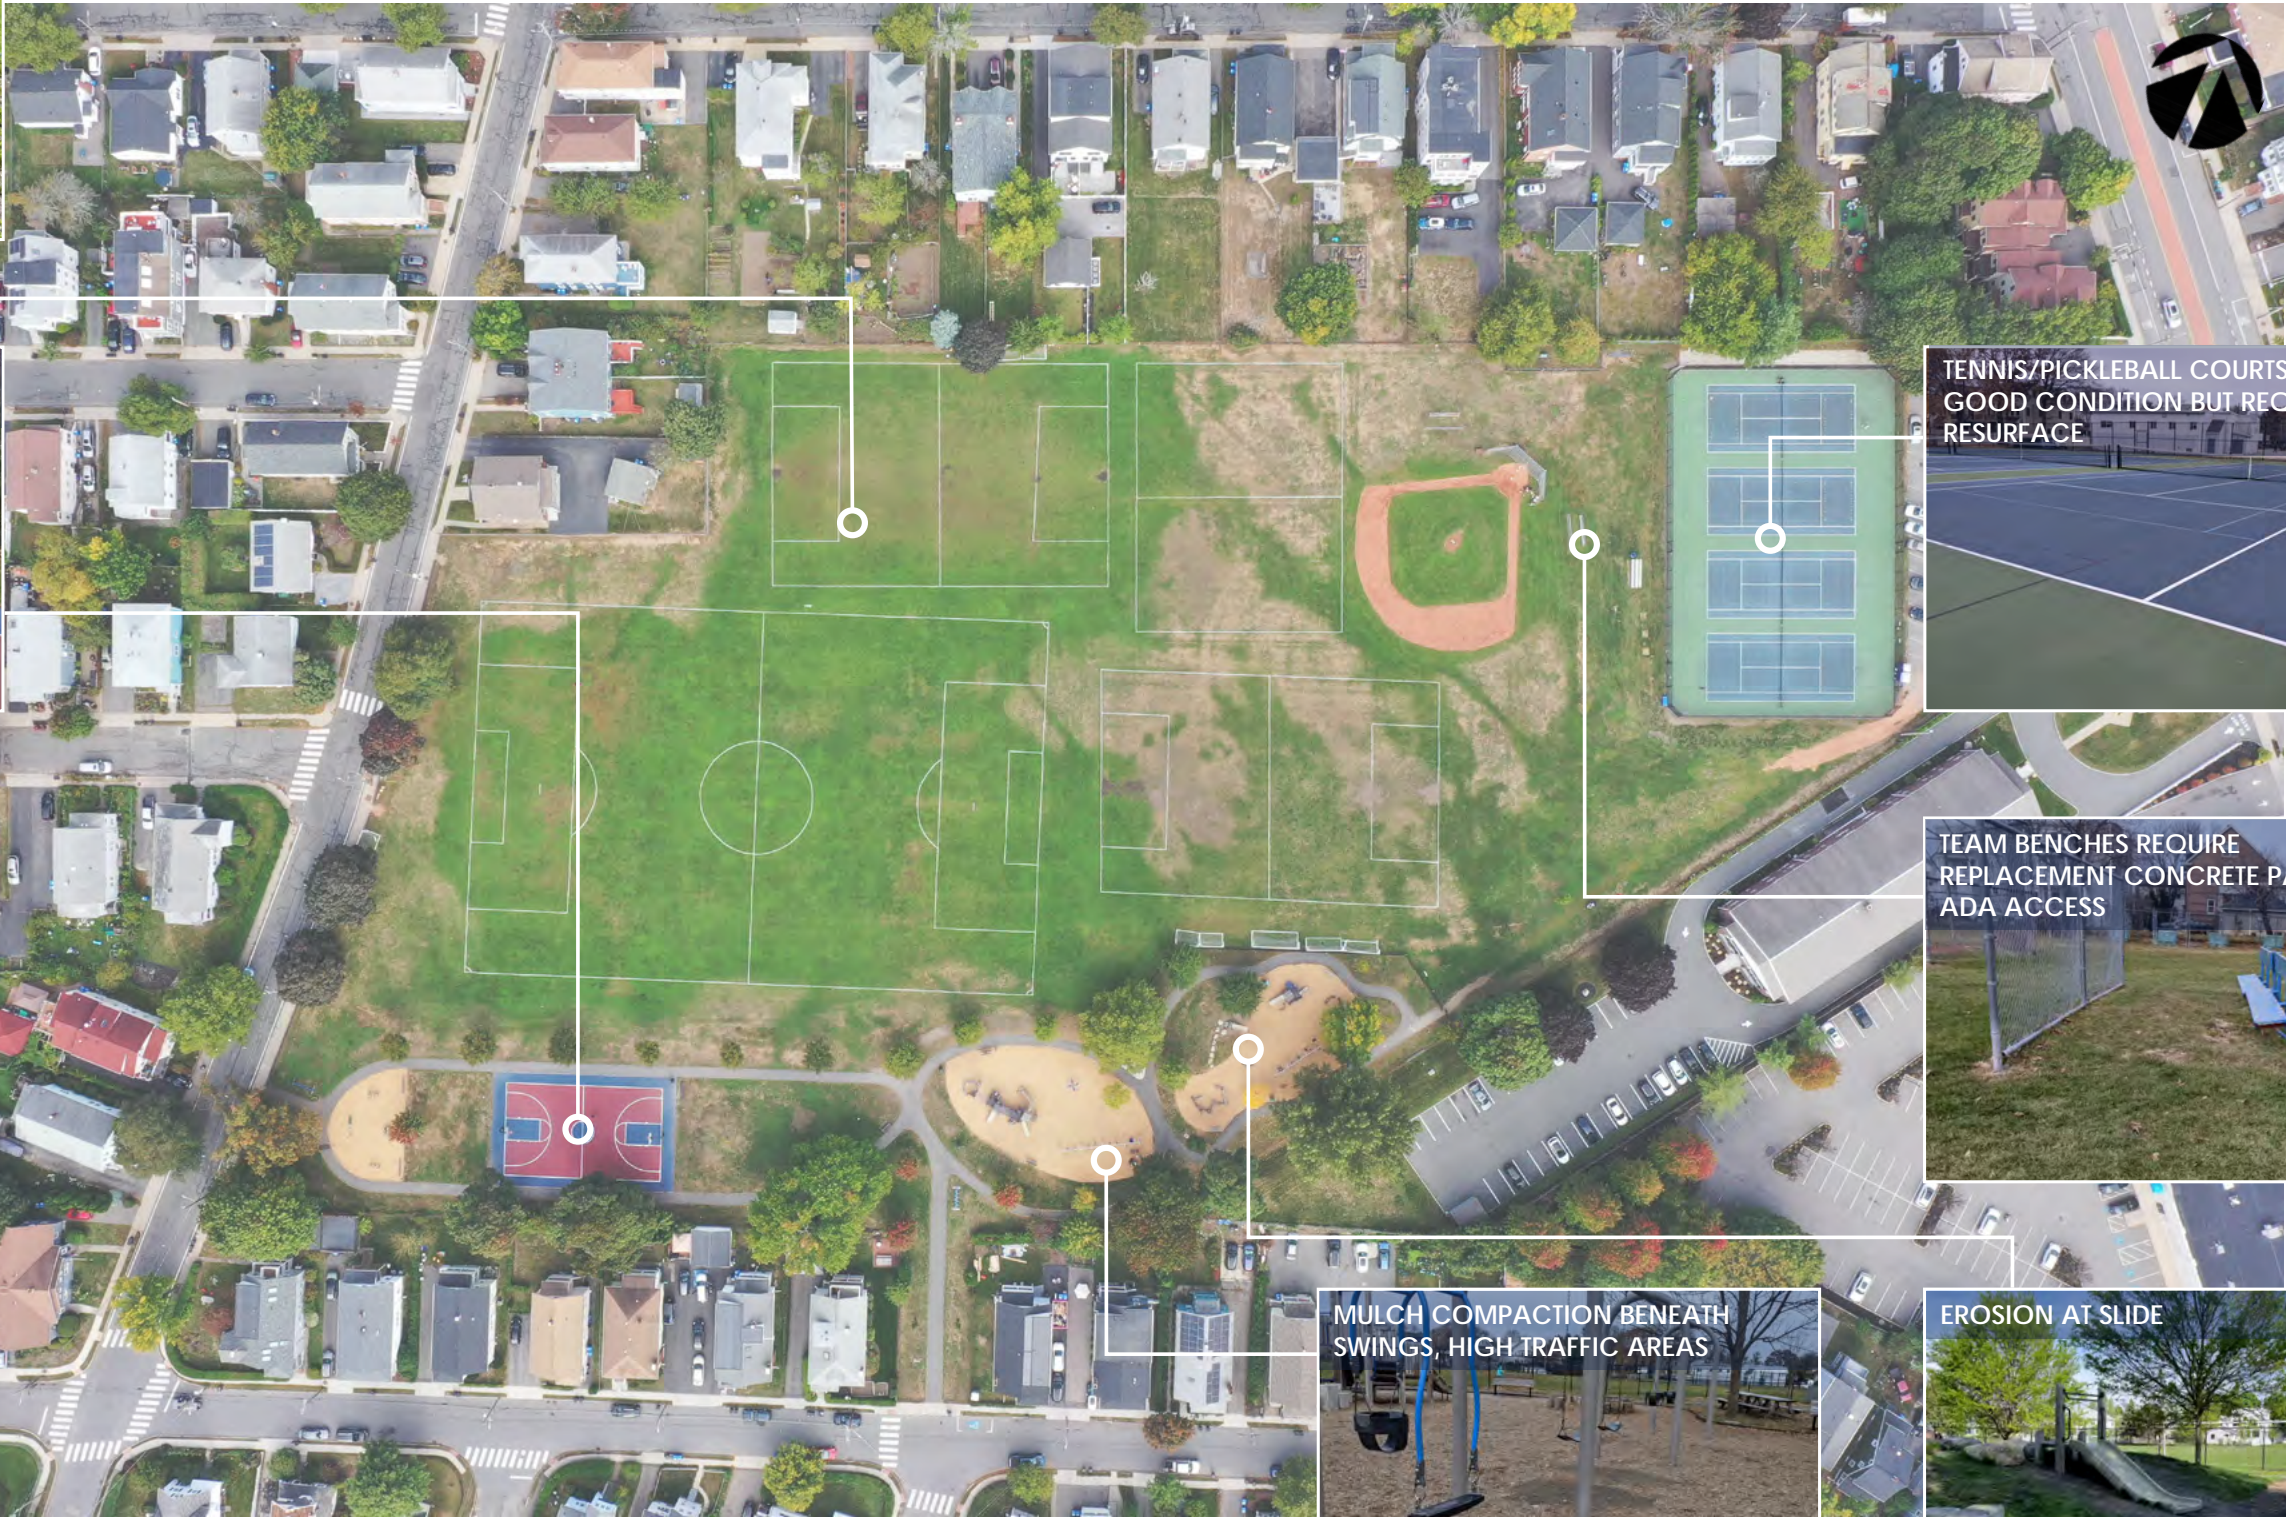
Grass cover is increasingly poor. There are many areas of bare soil at high use areas. Overall, the fields are well-graded, but densely weeded patches with variable growth rates result in a surface that feels uneven underfoot. The entire field should be stripped and resodded to promote quick establishment and prevent weeds from overtaking. Large areas of broad-leaved weeds like clover create slippery and hazardous conditions for athletes.

The reconstruction of the basketball courts is in progress. The CPC approved \$124,592 to complete this work in 2023. As part of this process, the hoops have been replaced with adjustable goals.

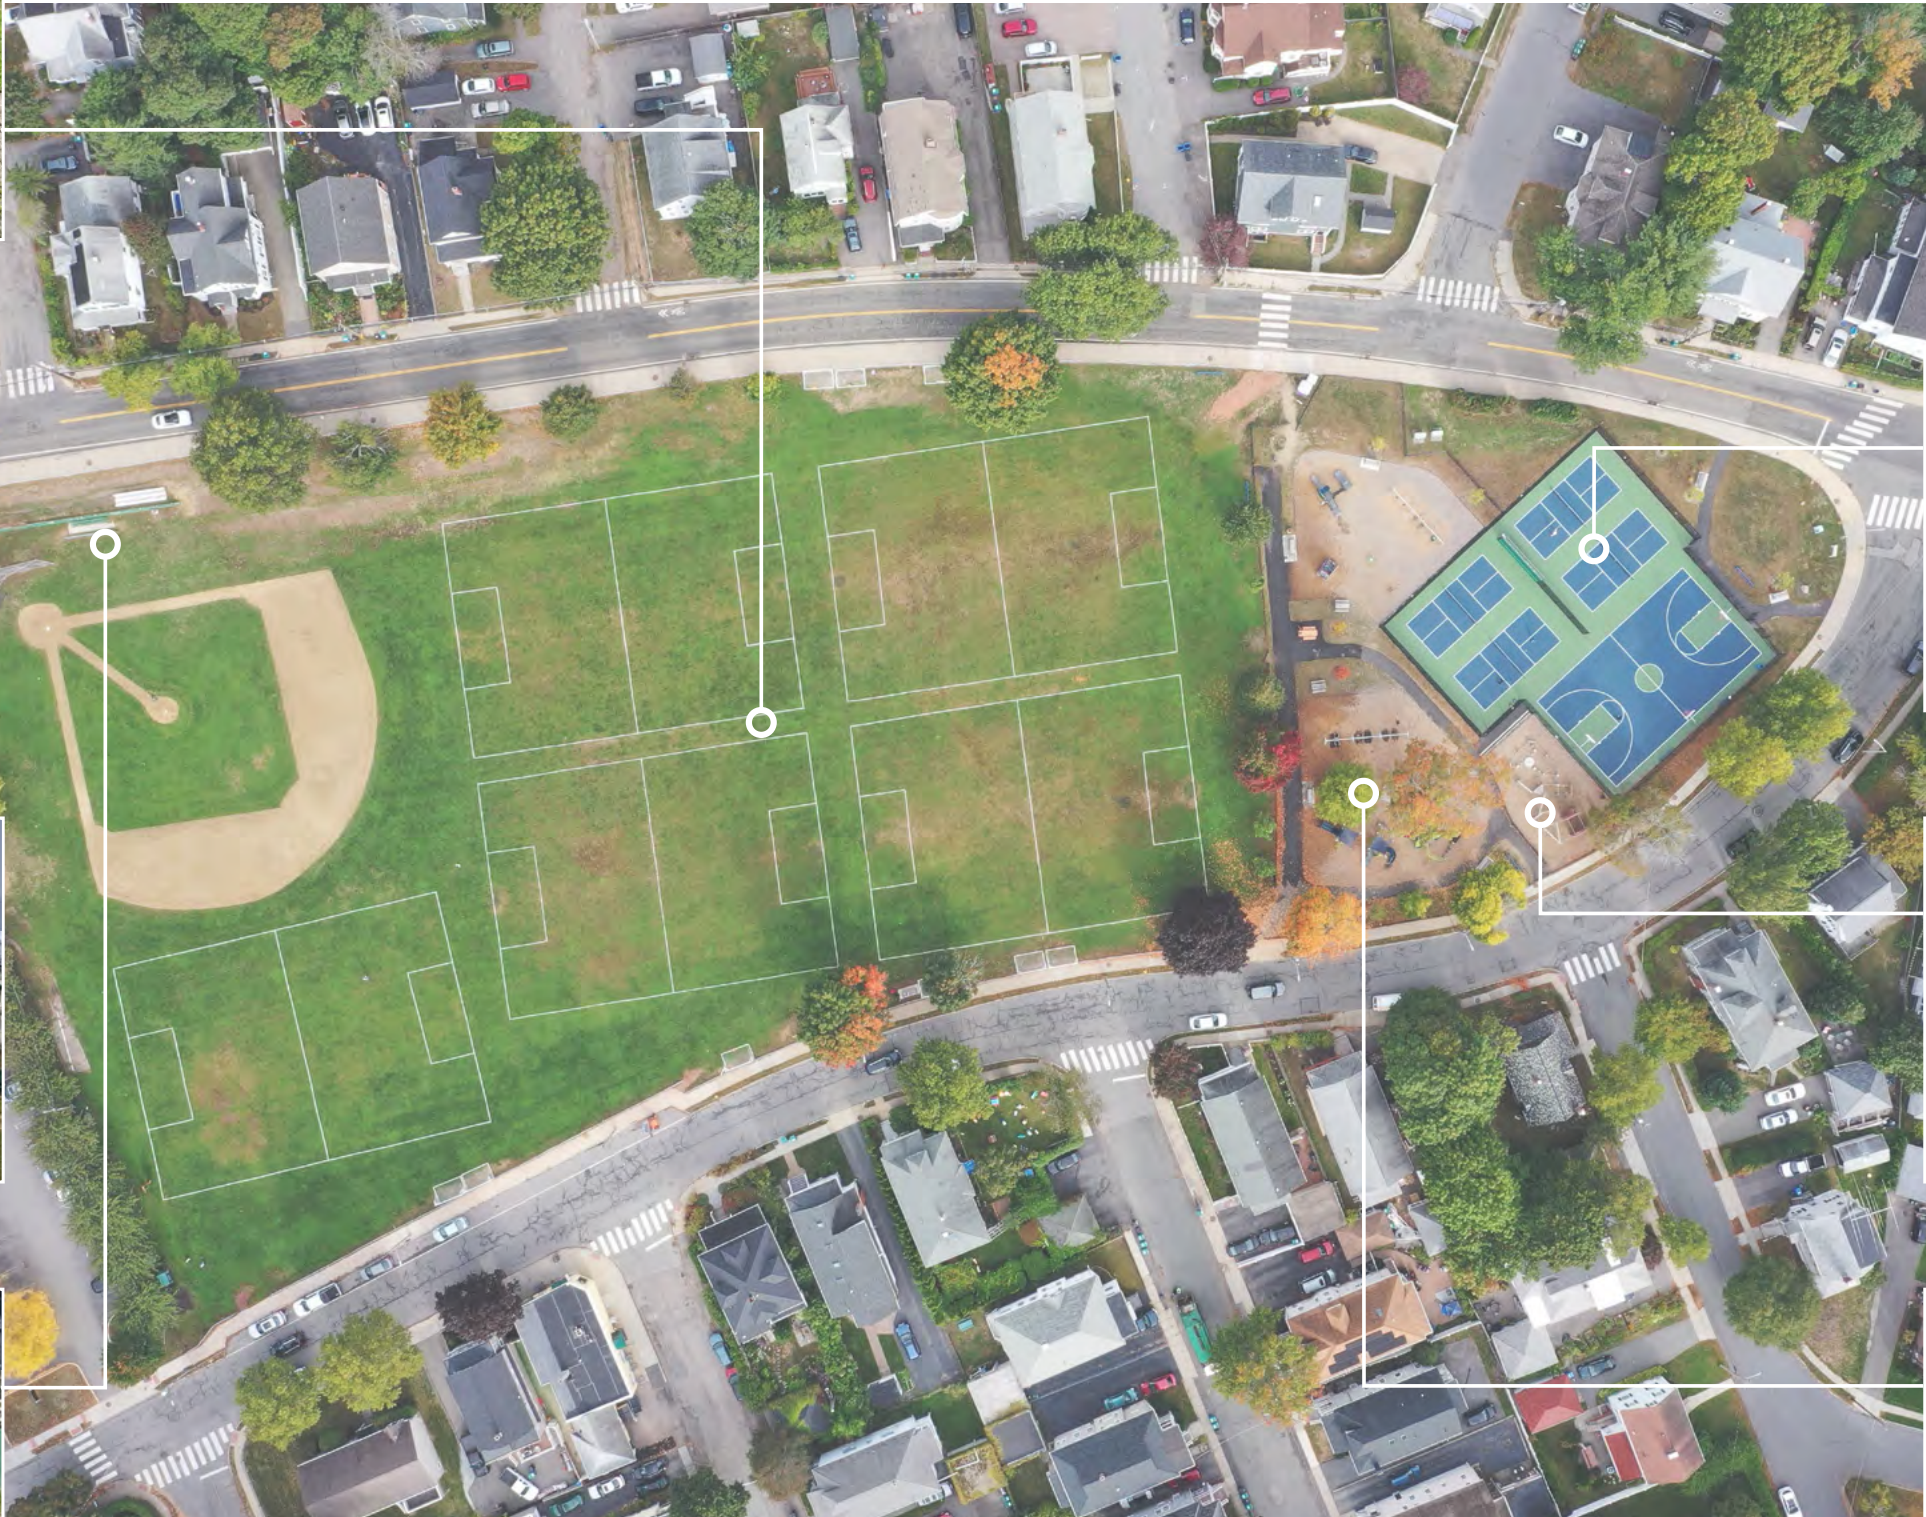
The baseball infield is free of weeds but the pitching mound has collapsed, and there is evidence that dogs are digging (2). The baseball field has two dugouts, each with a team bench on a concrete pad. The bench on the third baseline is warped in the center and warrants replacement. A paved route should be provided to each dugout and behind the backstop to promote accessibility.

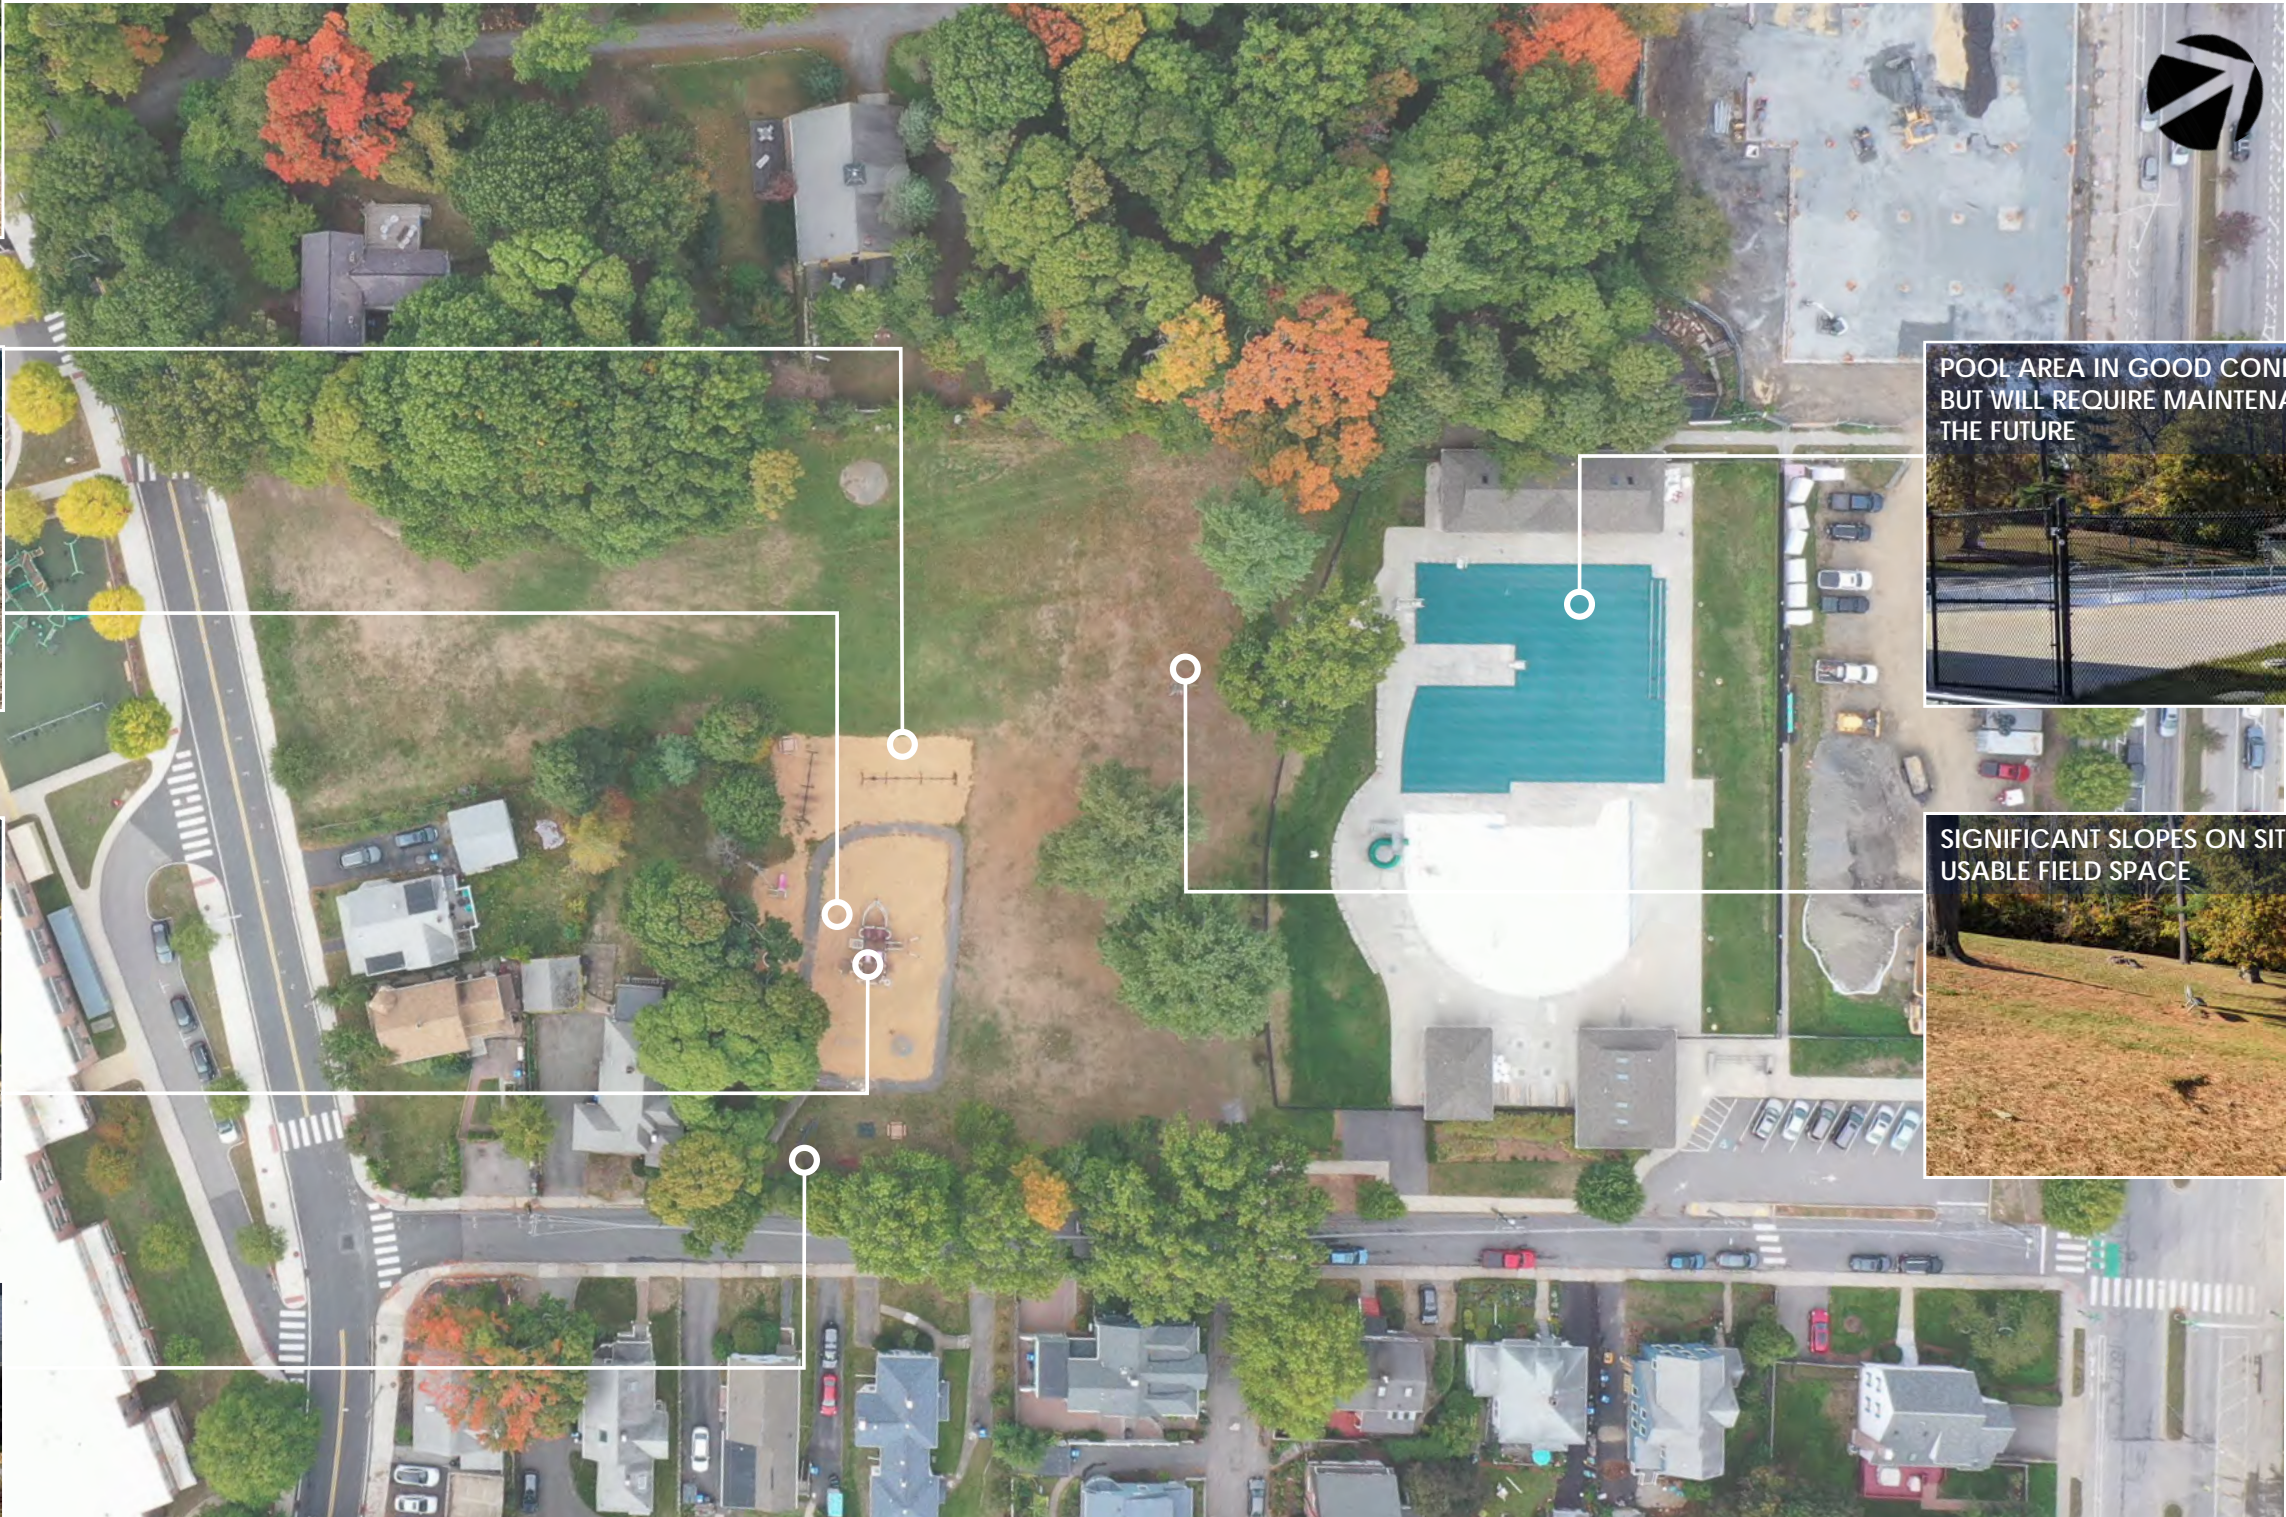
The grass cover and quality in this park is very good (90-95% cover), though there are many broad-leaved weeds including dandelions. Significant slopes across all of the lawn areas preclude most recreational athletic uses. The largest level field space is located next to the pool, adjacent to Concord Avenue, but is used for stormwater retention and is frequently inundated with mud.

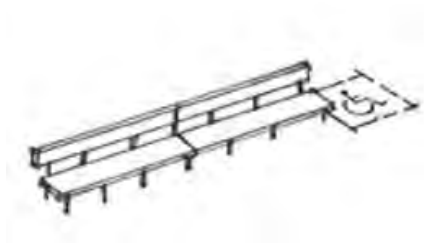
Diagram above shows an accessible space alongside team seating.

- Ensure there is an accessible route to all elements in the park/outdoor space (baseball fields, basketball courts, playgrounds, picnic areas, toilet facilities, etc.).
- Ensure there is a clear floor space adjacent to the bench at team seating areas and spectator seating areas such as bleachers at the baseball fields, basket courts, etc:

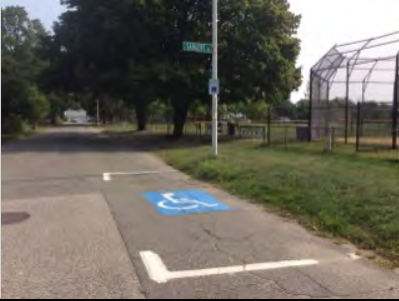
ID	Location	Floor	Room	Element	Type	Photo	Issues	Current Measure	Recommendations	Quantity	Price	Cost Estimation
Approach and Entrance												
Exterior Access Route												
1	Grosvenor Street Parking by Sargent Road and West Baseball Field	Ext.		Exterior Access Route	Exterior

Not provided from all site arrival points	-	Ensure an accessible route is provided from all points of arrival including the accessible parking space on Grosvenor Street. (Cost estimate for 40' long by 4' wide asphalt path to the entrance.)	1	1600	\$1600
2	Route to Batting Cages	Ext.		Exterior Access Route	Walkway

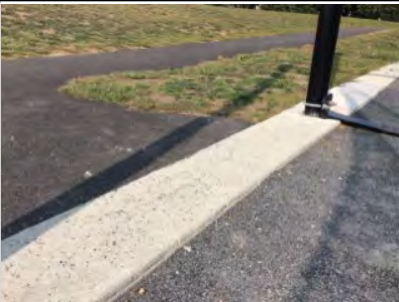
Level changes > 1/4"	1"	Alter change in level to be 1/4" high max.	1	160	\$160
3	Bike Rack by Playground	Ext.		Exterior Access Route	Exterior

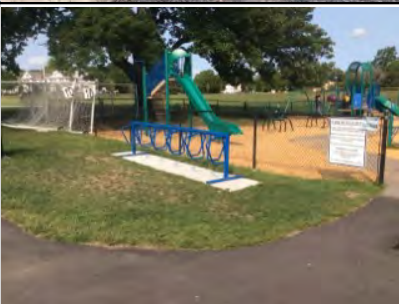
Accessible route not provided	-	Ensure an accessible route is provided to the bike racks. (Cost estimate for 30' long by 4' wide asphalt route.)	1	1200	\$1200

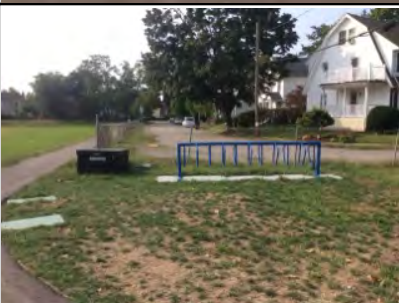
4	Bike Rack by Soccer Fields	Ext.		Exterior Access Route	Walkway

Accessible route not provided	-	Ensure an accessible route is provided to the bike rack. (Cost estimate for 25' long by 4' wide asphalt route.)	1	1000	\$1000
5	Bike Rack by Tennis Courts	Ext.		Exterior Access Route	Walkway

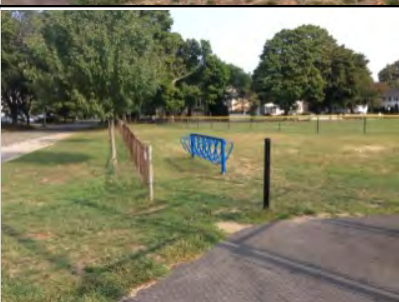
Accessible route not provided	-	Ensure an accessible route is provided to the bike racks. (Cost estimate for 30' long by 4' wide asphalt route.)	1	1200	\$1200

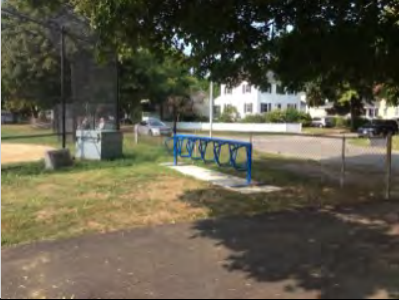
ID	Location	Floor	Room	Element	Type	Photo	Issues	Current Measure	Recommendations	Quantity	Price	Cost Estimation
6	Bike Rack by West Baseball Field	Ext.		Exterior Access Route	Walkway

Accessible route not provided	-	Ensure an accessible route is provided to the bike rack. (Cost estimate for 20' long by 4' asphalt route.)	1	800	\$800
7	Defibrillator	Ext.		Exterior Access Route	Exterior	 	Accessible route not provided	-	Ensure an accessible route is provided to the defibrillator. (Cost estimate for 7' long 4' wide asphalt area.)	1	280	\$280
8	Entrance From Grove Street by Basketball Court	Ext.		Exterior Access Route	Walkway	 	Accessible route not provided	-	Ensure an accessible route is provided. (Cost estimate for 100' long by 4' wide asphalt route to the basketball court and walking path to the batting cages from the entrance.)	1	4000	\$4000
9	Entrance From Grove Street by Basketball Court, Bike Rack	Ext.		Exterior Access Route	Walkway	 	Accessible route not provided	-	Ensure an accessible route is provided to the bike racks. (Cost estimate for 30' long by 4' wide asphalt route.)	1	1200	\$1200

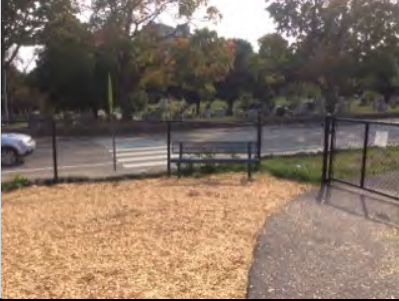
10	Playground	Ext.		Exterior Access Route	Walkway

Accessible route not provided	-	Ensure an accessible route is provided to one bench in the playground. (Cost estimate for 10' long by 4' wide asphalt route.)	1	400	\$400

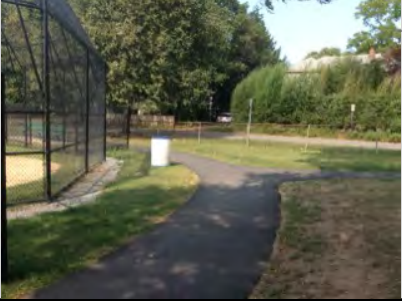
ID	Location	Floor	Room	Element	Type	Photo	Issues	Current Measure	Recommendations	Quantity	Price	Cost Estimation
11	Walking Path Behind Northeast Baseball Diamond	Ext.		Exterior Access Route	Walkway

Accessible route not provided	-	Relocate trash bin to an accessible route.	1	256	\$256
Off-Street Parking Lot or Garage												
12	Parking Lot by Tennis Court	Ext.		Off-Street Parking Lot or Garage	Visitor

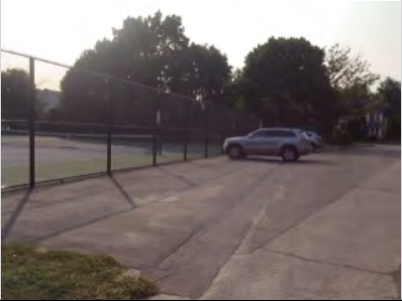
Total # of parking Total # of designated accessible parking spaces	10 0	Provide one van accessible parking space.	1	1850	\$1850
13	Accessible Parking Space on Foster Road	Ext.		Off-Street Parking Lot or Garage	Visitor

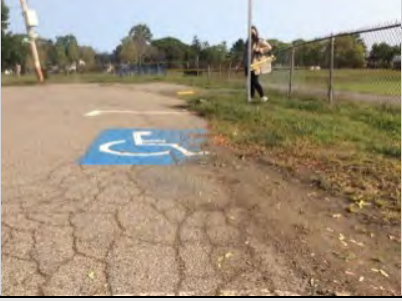
Surface not stable, firm, and slip-resistant	-	Repair surface at accessible parking space.	1	192	\$192
Access to Goods and Services												
Signage												
14	Playground Entrance	Ext.		Signage	Informational

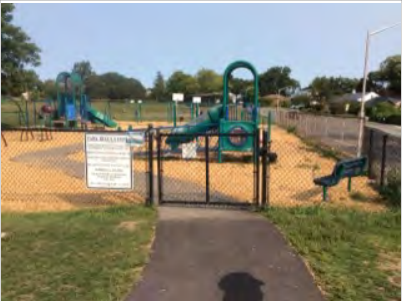
Visual characters < 40" above ground	-	Mount visual sign so that the baseline of the lowest character is 40" min. above the ground.	1	Labor	\$0

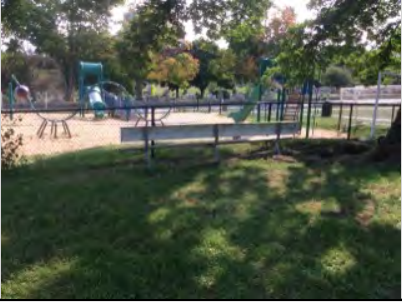
ID	Location	Floor	Room	Element	Type	Photo	Issues	Current Measure	Recommendations	Quantity	Price	Cost Estimation
Exterior Benches												
15	Bench Under Tree by Playground	Ext.		Exterior Benches	N/A

No accessible route to one bench in area	-	Provide an accessible route to this bench. (Cost estimate for 20' long by 4' wide asphalt route.)	1	800	\$800
Additional Access												
Drinking Fountains												
16	Drinking Fountain by Gosvenor Street	Ext.		Drinking Fountains	Low

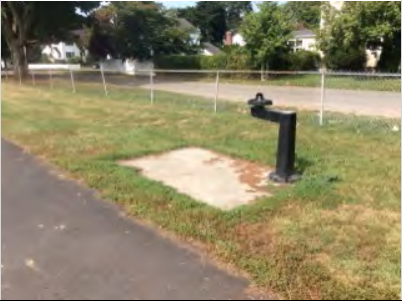
Fountain not on accessible route	-	Ensure an accessible route is provided to the drinking fountain. (Cost estimate for 6' long by 4' wide route.)	1	240	\$240
17	Drinking Fountain by Gosvenor Street	Ext.		Drinking Fountains	Low

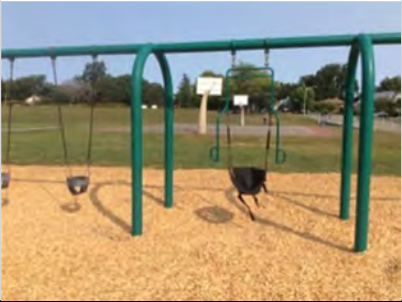
18	Playground	Ext.		Play Areas	N/A

Accessible route not provided around playground	-	Provide an accessible route around the play area on the north and northwest side. (Note: Other routes may be too close to the area that is required to be impact attenuating.) (Cost estimate for 103' long by 4' wide asphalt route.)	1	4120	\$4120

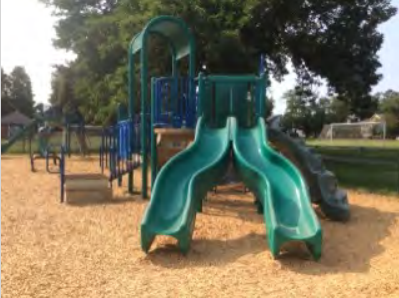
Accessible route not provided to play components	-	Provide a compliant impact-attenuating surface to and around the play components. (Cost estimate for 2,948 sq. ft. of poured in place rubber surface.)	1	41272	\$41272
20	Playground	Ext.		Play Areas	N/A

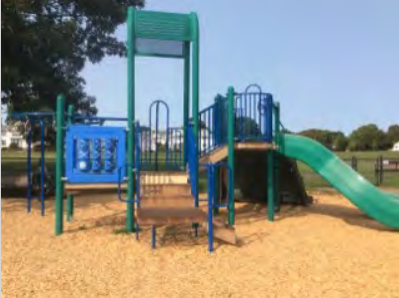
No compliant transfer system	21"	Alteration might be technically infeasible. When replacing surface, attempt to ensure that the transfer platform is 11" to 18" above the ground.	1	-	\$0
Field												
21	Northeast Baseball Diamond, First Base Team Seating Area	Ext.		Field	Baseball

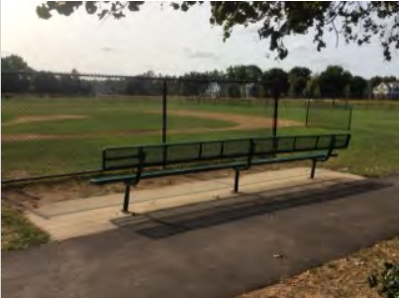
Accessible spaces not provided at team seating Field not connected to an accessible route	28" -	Provide a 36" x 48" clear floor space at team seating. Provide an accessible route to the field from the team seating area. (Cost estimate for 6' long by 4' wide asphalt area.)	1	240	\$240

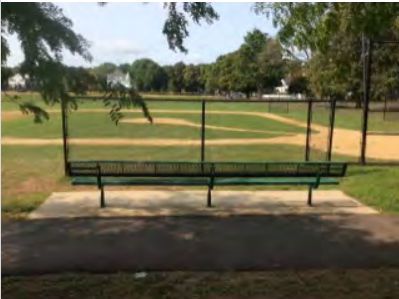
22	Northeast Baseball Diamond, Third Base Team Seating Area	Ext.		Field	Baseball

Accessible spaces not provided at team seating Field not connected to an accessible route	23.5" -	Provide a 36" x 48" clear floor space at team seating. Provide an accessible route to the field from the team seating area. (Cost estimate for 6' long by 4' wide asphalt area.)	1	240	\$240
23	West Baseball Field, Team Seating by First Base	Ext.		Field	Baseball

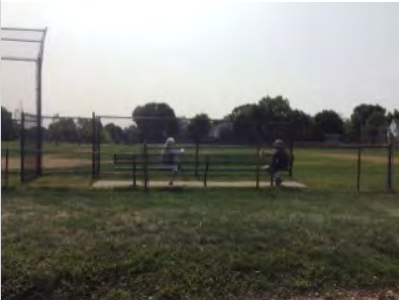
Accessible spaces not provided at team seating Field not connected to an accessible route	23" -	Provide a 36" x 48" clear floor space at team seating. Provide an accessible route to the field from the team seating area and from the entrance walkway to the team seating area. (Cost estimate for 50' long by 4' wide asphalt route.)	1	2000	\$2000

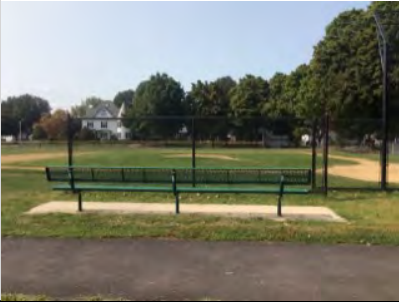
ID	Location	Floor	Room	Element	Type	Photo	Issues	Current Measure	Recommendations	Quantity	Price	Cost Estimation
24	West Baseball Field, Team Seating by Third Base	Ext.		Field	Baseball

Accessible spaces not provided at team seating Field not connected to an accessible route	23" -	Provide a 36" x 48" clear floor space at team seating. Provide an accessible route to the field from team seating. (Cost estimate for 10' by 4' asphalt area.)	1	400	\$400
25	Central Baseball Field by Tennis Courts, First Base Team Seating Area	Ext.		Field	Baseball

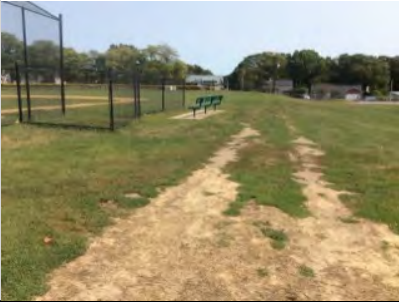
Accessible spaces not provided at team seating No accessible route to all areas of sport activity	24" -	Provide a 36" x 48" clear floor space at team seating. Install an accessible route between all areas of sport activity. (Cost estimate for 75' long 4' wide asphalt area.)	1	3000	\$3000
26	Central Baseball Field by Tennis Courts, Third Base Team Seating Area	Ext.		Field	Baseball

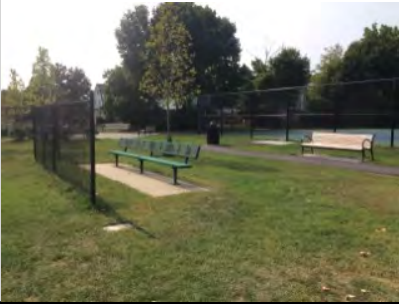
Accessible spaces not provided at team seating No accessible route to all areas of sport activity	- -	Provide a 36" x 48" clear floor space at team seating. Install an accessible route between all areas of sport activity including to the team seating area and from the team seating area to the field. (Cost estimate for 40' long by 4' wide asphalt area.)	1	1600	\$1600

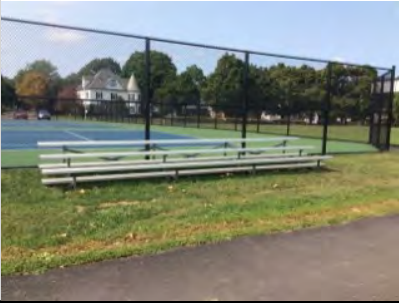
27	Central Baseball Field by Tennis Courts	Ext.		Field	Baseball

Accessible spaces not provided at sidelines seating No accessible route to all areas of sport activity	- -	Provide a 36" x 48" clear floor space at sidelines seating on each side. Install an accessible route to each side of bleacher. (Cost estimate for two 10' long by 4' wide asphalt routes.)	2	400	\$800
28	Northeast Baseball Diamond	Ext.		Field	Baseball

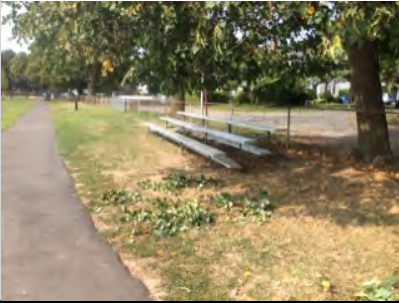
Accessible spaces not provided at sidelines seating No accessible route to all areas of sport activity	- -	Provide a 36" x 48" clear floor space at sidelines seating on each side. Install an accessible route to each side of bleacher. (Cost estimate for two 10' long by 4' wide asphalt routes.)	2	400	\$800

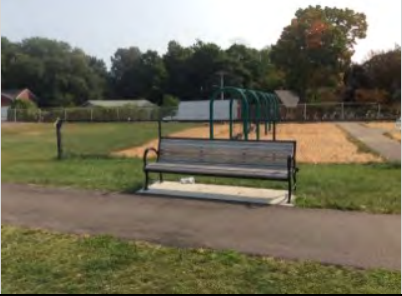
-	Recommend providing clear floor space alongside one bench in each area of the park so that a person using a wheelchair or wheeled mobility device can sit shoulder to shoulder with a person seated on the bench.	1	-	\$0

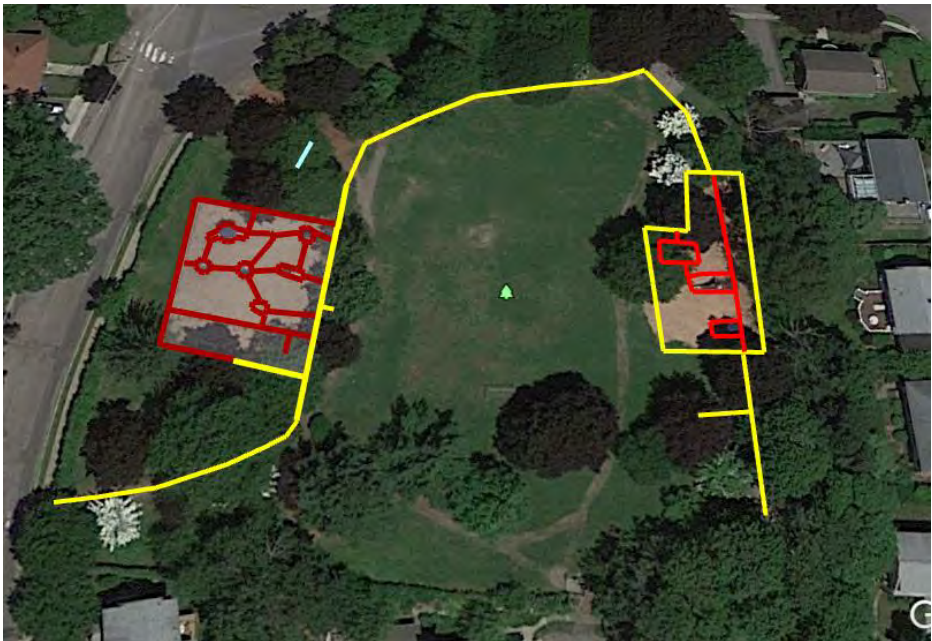
Accessibility issues include lack of an accessible route to and around the two playgrounds. There is also a lack of an impact-attenuating accessible route to the play components inside the boundary of the playgrounds. See the following diagram depicting accessible routes to and around the playgrounds from entrances (in yellow) and to the play components in the playgrounds (in red). A stone dust route to the bike rack is shown in light blue.

Note: The ADA allows engineered wood fiber as an accessible surface when it is installed properly and maintained to be stable, firm and slip-resistant. Engineered wood fiber surfaces will require frequent maintenance to comply because of surface displacement due to weather, user activity and other factors.

The Massachusetts Architectural Access Board (MAAB) has long considered engineered wood fiber and wood chips as noncompliant and problematic materials. While it reserves the right to reevaluate this in the future, it is currently MAAB’s opinion that such material is not clearly compliant with the requirements of 521 CMR.

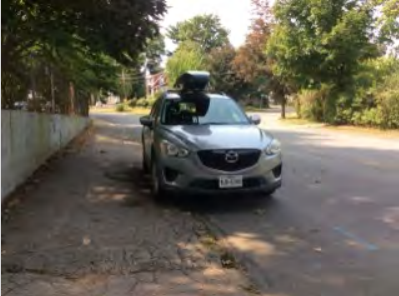
Cross slope > 1:50 (2.00%)	7.4%	Reduce cross slope to be no steeper than 1:50 (2.00%).(Cost estimate to renovate 100' of sidewalk.)	1	4000	\$4000
2	Main Entrance	Ext.		Exterior Access Route	Walkway

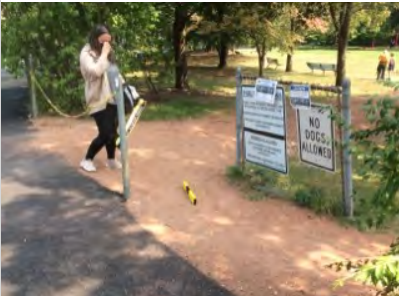
Running slope > 1:20 (5%)	7.8%	Reduce running slope to be no steeper than 1:20 (5%). (Cost estimate for 10' long, 4' wide asphalt route.)	1	400	\$400
3	Walkway by Main Entrance	Ext.		Exterior Access Route	Walkway

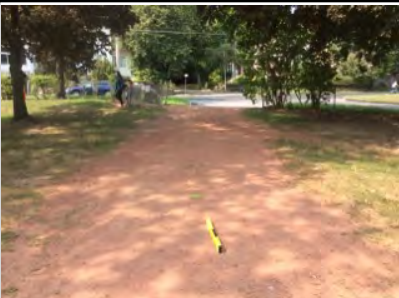
Running slope > 1:20 (5%)	6.5%	Reduce running slope to be no steeper than 1:20 (5%). (Cost estimate for 10' long, 4' wide route.)	1	400	\$400
4	South Payson Street Entrance	Ext.		Exterior Access Route	Exterior

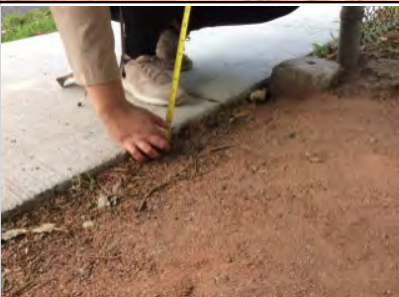
Level changes > 1/4"	1.25"	Alter change in level to be 1/4" high max.	1	160	\$160

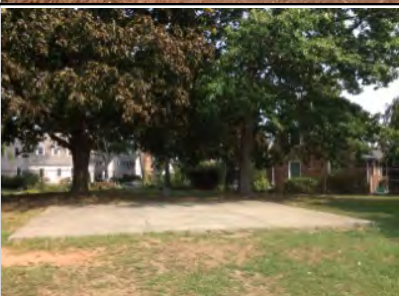
5	Band Stand	Ext.		Exterior Access Route	Walkway

Accessible route not provided	-	Ensure an accessible route is provided. (Cost estimate for 177' long, 4' wide asphalt walkway.)	1	5664	\$5664

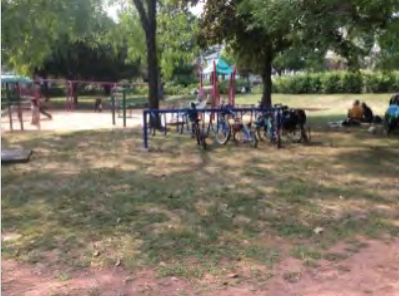
Accessible route not provided	-	Ensure an accessible route is provided to the bike rack. (Cost estimate for 15' long, 4' wide stone dust route.)	1	480	\$480
7	Bulletin Board and Defibrillator in Grass Field by Picnic Area	Ext.		Exterior Access Route	Walkway

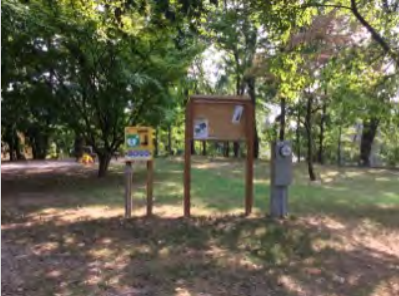
Accessible route not provided	-	Ensure an accessible route is provided. (Cost estimate for 24' long, 4' wide asphalt route.)	1	960	\$960
8	Walking Route Between Playground and South Payson Street Entrance	Ext.		Exterior Access Route	Exterior

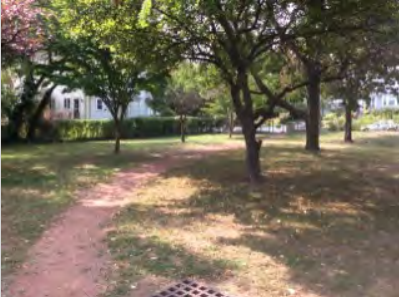
Accessible route not provided	-	Provide an accessible route. (Cost estimate for 4' wide by 109' long asphalt route.)	1	4360	\$4360
9	Walking Route on North Side	Ext.		Exterior Access Route	Exterior

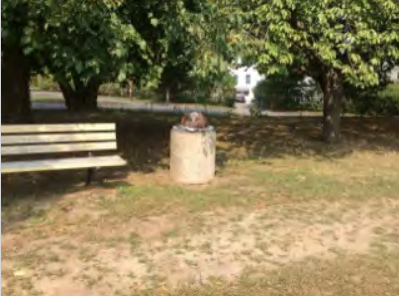
Accessible route not provided	-	Ensure an accessible route is provided to the trash container. (Cost estimate for 6' long by 4' wide asphalt route.)	1	240	\$240

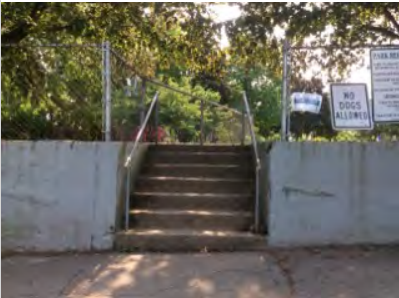
Entrance												
10	Elm Street Entrance	Ext.		Entrance	Secondary Entrance

Directional sign to accessible entrance not provided	-	Provide a directional sign indicating the location of the nearest accessible entrance.	1	346	\$346

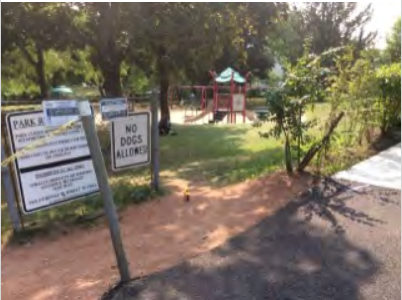
Visual characters < 40" above ground	-	Mount visual sign so that the baseline of the lowest character is 40" min. above the finished floor.	1	Labor	\$0
Picnic Tables												
13	Gravel Picnic Area on Southeast Side	Ext.		Picnic Tables	N/A

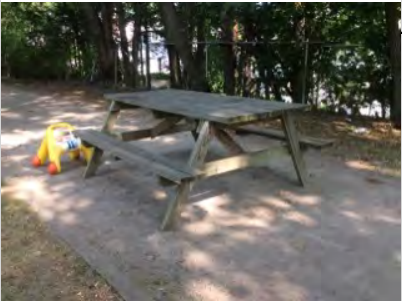
Toe or knee clearance at tables not provided	6"	Provide at least 1 picnic table with knee and toe clearance that is 17" deep minimum.	1	1400	\$1400
14	Gravel Picnic Area on Southeast Side	Ext.		Picnic Tables	N/A

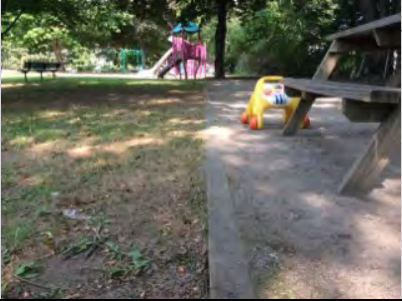
Picnic table not on an accessible route	-	Ensure that the dining surface is connected to an accessible route. (Cost estimate for a 75' long, 4' wide asphalt route to the picnic table.)	1	3000	\$3000

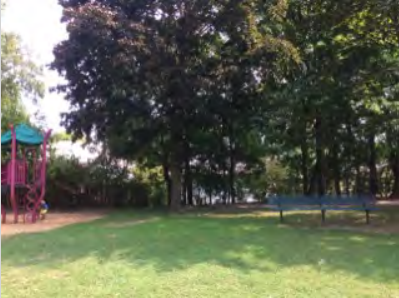
No accessible route to one bench in area	-	Provide an accessible route to the bench. (Cost estimate for 10' long by 4' wide asphalt route.)	1	400	\$400
16	Walking Route on North Side	Ext.		Exterior Benches	N/A
