RECREATIONAL FACILITIES INVENTORY

2024 UPDATE

TOWN OF BELMONT | OCTOBER 11, 2024

In the fall of 2021, Activitas, Inc. was retained by the Town of Belmont to perform a comprehensive inventory, conditions review and usage analysis of the following town-owned parks:

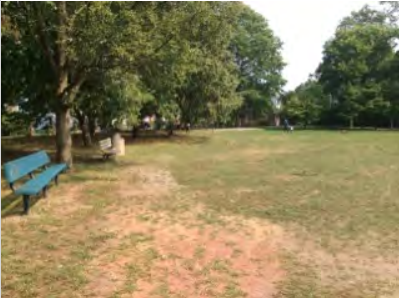
No accessible route to one bench in area	-	Provide an accessible route to one bench in this area. (Cost estimate based on 6' long, 4' wide asphalt route.)	1	240	\$240
17	West Playground	Ext.		Exterior Benches	N/A

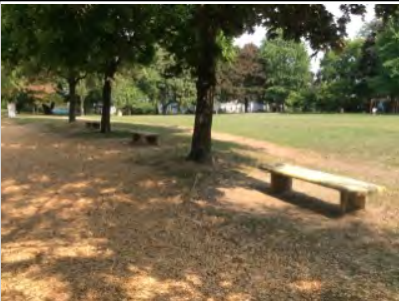
No accessible route to one bench in area	-	Provide an accessible route to one bench. (Cost estimate for 4' wide by 5' long asphalt route.)	1	200	\$200
Play and Sport Areas												
Play Areas												
18	East Playground	Ext.		Play Areas

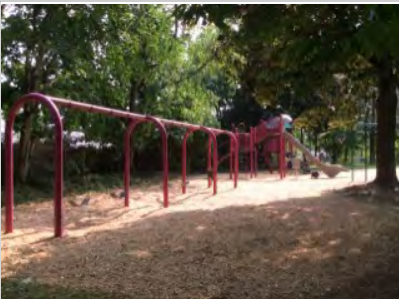
Accessible route not provided to playground	-	Install an accessible route to the playground. (Cost estimate for 66' long by 4' wide asphalt route.)	1	3300	\$3300

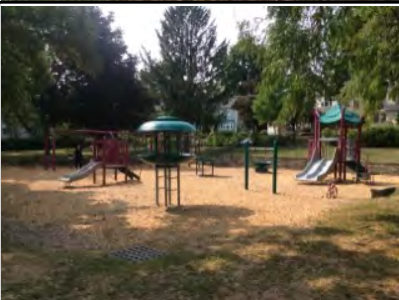
19	West Playground	Ext.		Play Areas	N/A

Accessible route not provided to playground Accessible route not provided around playground	- -	Install an accessible route to and around the playground. (Cost estimate for 150 ft. long, 4 ft. wide stone dust route to and around the playground.)	1	4800	\$4800

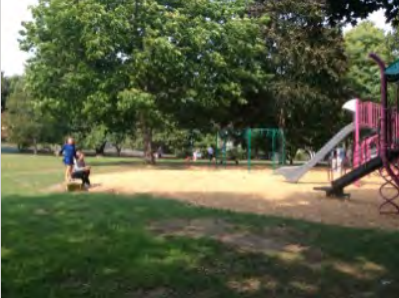
Accessible route not provided around playground	-	Provide an accessible route around the play area (including route to at least one bench). (Cost estimate for 288' long by 4' wide asphalt route around playground.)	1	11520	\$11520
21	East Playground	Ext.		Play Areas	N/A

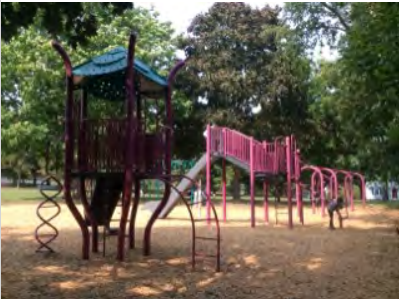
Accessible route not provided to play components	-	Provide a compliant impact-attenuating surface to and around the play components. (Cost estimate for 1,250 sq. ft. of poured in place rubber surface.)	1	17500	\$17500
22	West Playground	Ext.		Play Areas	N/A

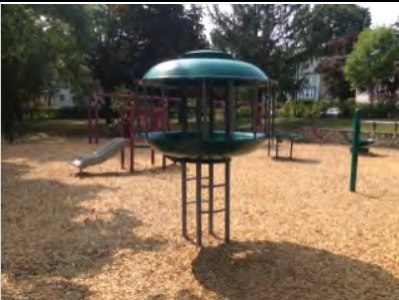
Accessible route not provided to play components	-	Provide a compliant impact-attenuating surface to and around the play components. (Cost estimate for 2,917 sq. ft. of poured in place rubber surface.)	1	40838	\$40838

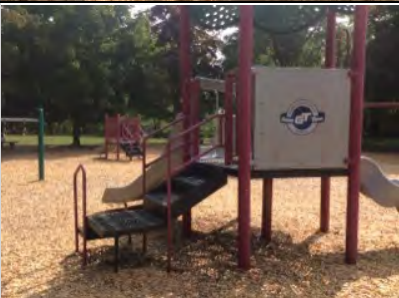
23	West Playground	Ext.		Play Areas	N/A

No compliant transfer system	20.75"	Alteration of component might be technically infeasible. When playground is resurfaced with poured-in-place rubber ensure that transfer platform is 11" to 18" high above the ground surface.	1	Labor	\$0
Field												
24	Grass Field With Soccer Net	Ext.		Field	Soccer

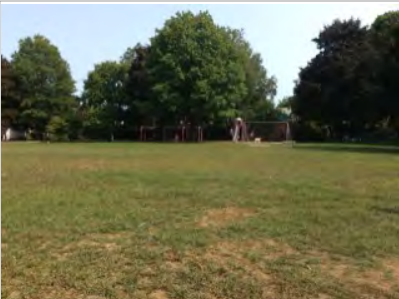
Field not connected to an accessible route	-	Provide an accessible route to the field. (Cost estimate for 4' wide by 5' long stone dust route.)	1	160	\$160
Best Practice

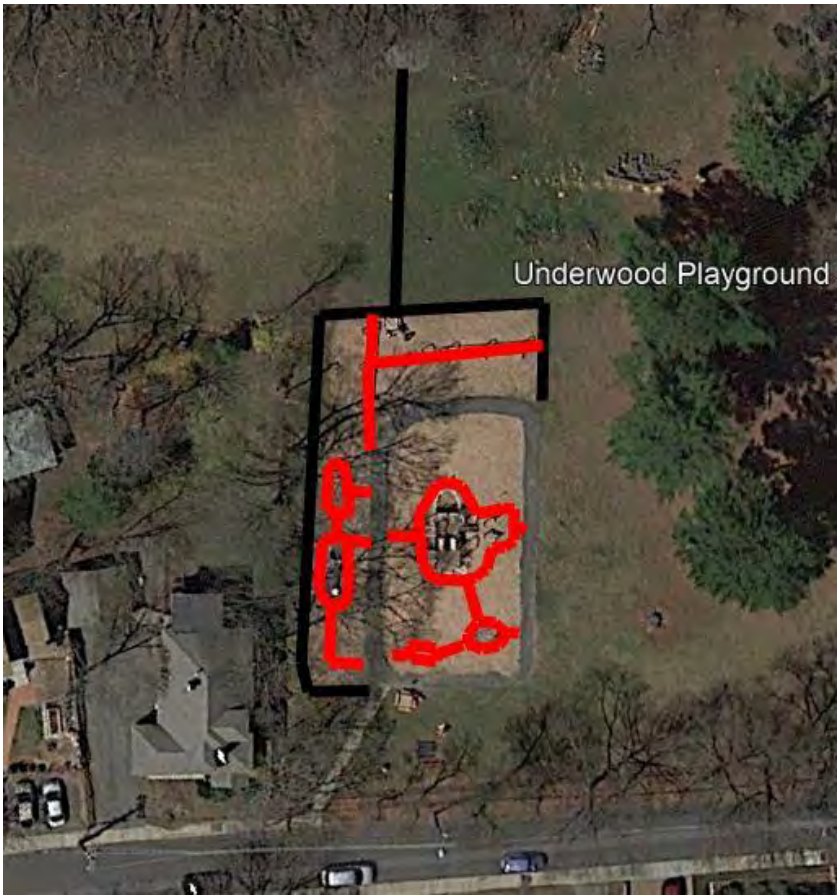
Accessibility issues include lack of an accessible route around the playgrounds with the swings and slides. There is also a lack of an impact attenuating accessible route to the play components inside the boundary of the playgrounds. See the following diagram depicting accessible routes around the playgrounds (in black) and to the play components in the playgrounds (in red). The route to the tetherball court is also shown:

Note: The ADA allows engineered wood fiber as an accessible surface when it is installed properly and maintained to be stable, firm and slip-resistant. Engineered wood fiber surfaces will require frequent maintenance to comply because of surface displacement due to weather, user activity and other factors.

The Massachusetts Architectural Access Board (MAAB) has long considered engineered wood fiber and wood chips as noncompliant and problematic materials. While it reserves the right to reevaluate this in the future, it is currently MAAB’s opinion that such material is not clearly compliant with the requirements of 521 CMR.

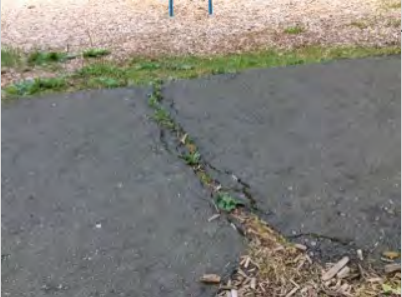
Route not maintained in operable working condition	-	Ensure the accessible route is maintained in operable working condition.	1	160	\$160
2	Sidewalk by Cottage Street Entrance	Ext.		Exterior Access Route	Sidewalk

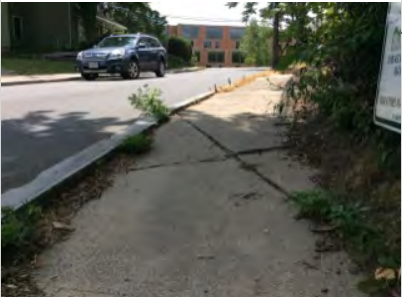
Route not maintained in operable working condition	-	Ensure the sidewalk is maintained in operable working condition.	1	Labor	\$0
3	South Playground Trash Bin	Ext.		Exterior Access Route	Walkway

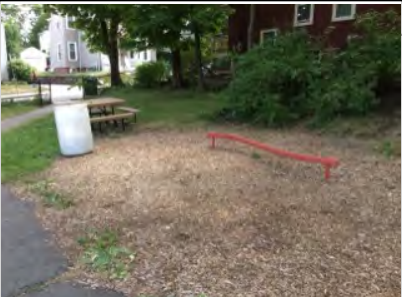
Accessible route not provided	-	Locate trash bin on an accessible route.	1	Labor	\$0
4	Bike Rack Along Walkway to Cottage Street Entrance	Ext.		Exterior Access Route	Walkway

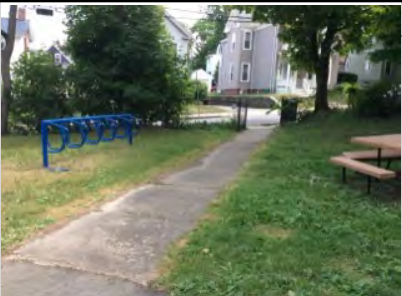
Accessible route not provided	-	Provide an accessible route to the bike rack. (Cost estimate for a 6' long 4' wide asphalt route.)	1	240	\$240

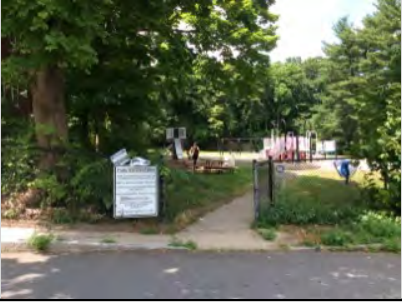
ID	Location	Floor	Room	Element	Type	Photo	Issues	Current Measure	Recommendations	Quantity	Price	Cost Estimation
Signage												
5	Park Entrance Signage	Ext.		Signage	Informational

Visual characters < 40" above ground	-	Mount visual sign so that the baseline of the lowest character is 40" min. above the finished floor.	1	Labor	\$0
Picnic Tables												
6	Main Playground Picnic Table	Ext.		Picnic Tables	N/A

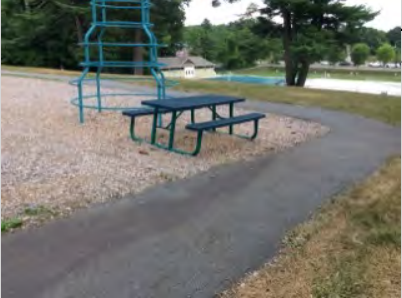
Toe or knee clearance at tables not provided Picnic table not on an accessible route	- -	Provide at least 1 dining surface that has toe and knee clearance. Locate the dining surface on an accessible route.	1	1400	\$1400
Exterior Benches												
7	Bench by Entrance and Bike Rack	Ext.		Exterior Benches	N/A

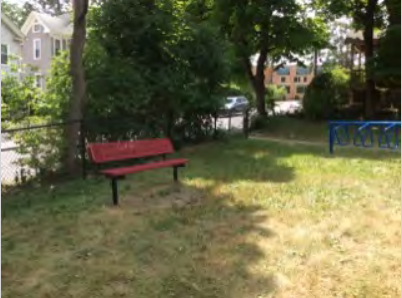
No accessible route to one bench in area	-	Provide an accessible route to at least one bench in the park. (Cost estimate for a 15' long 4' wide asphalt route to the bench.)	1	600	\$600

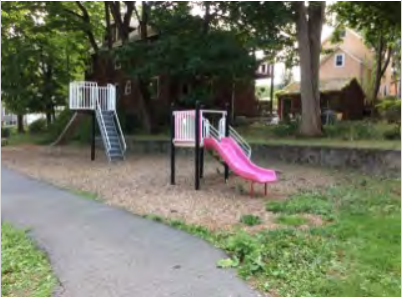
Accessible route not provided around playground	- -	Provide an accessible route around the play area with the slides and the play area with the swings. (Cost estimate for 256' long 4' wide asphalt route.)	1	10240	\$10240

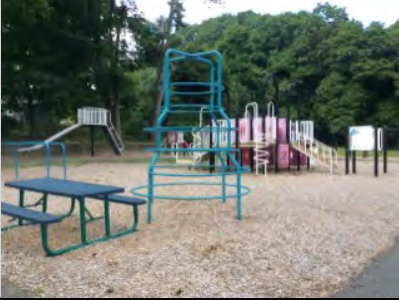
Accessible route not provided to play components	-	Provide a compliant impact-attenuating surface to and around the play components. (Cost estimate for 1300 sq. ft. of poured in place rubber surface.)	1	18200	\$18200
10	Bucket Swings	Ext.		Play Areas	N/A

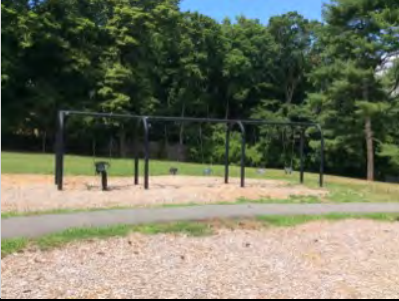
Accessible route not provided to play components	- -	Provide a compliant impact-attenuating surface to and around the play components. (Cost estimate for 456 sq. ft. of poured in place rubber surface.)	1	6384	\$6384
11	Standard Swings	Ext.		Play Areas	N/A

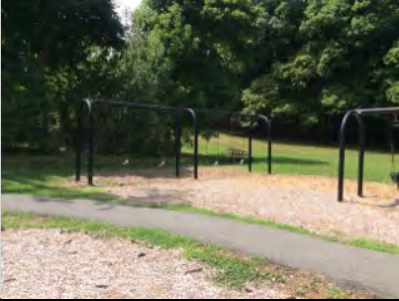
Accessible route not provided to play components	- -	Provide a compliant impact-attenuating surface to and around the play components. (Cost estimate for 174 sq. ft. of poured in place rubber surface.)	1	2436	\$2436
12	South Playground, Slide for Young Children	Ext.		Play Areas	N/A

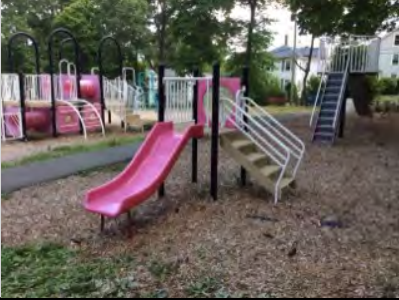
Accessible route not provided to play components	-	Provide a compliant impact-attenuating surface to and around the play components. (Cost estimate for 376 sq. ft. of poured in place rubber surface.)	1	5264	\$5264

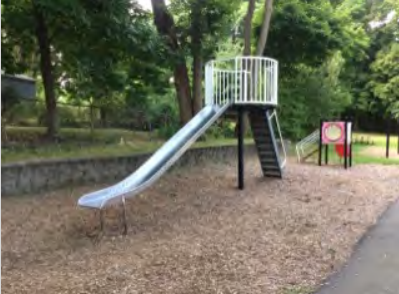
13	South Playground, Slide for Older Children	Ext.		Play Areas	N/A

Accessible route not provided to play components	-	Provide a compliant impact-attenuating surface to and around the play components. (Cost estimate for 396 sq. ft. of poured in place rubber surface.)	1	5544	\$5544

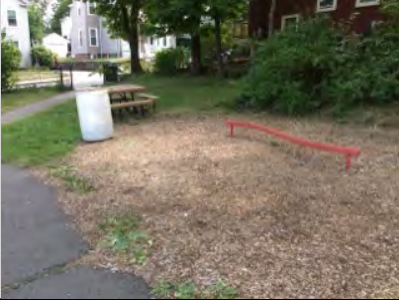
Accessible route not provided to play components	-	Provide a compliant impact-attenuating surface to and around the play components. (Cost estimate for 168 sq. ft. of poured in place rubber surface.)	1	2354	\$2354
Court												
15	Tetherball Court	Ext.		Court

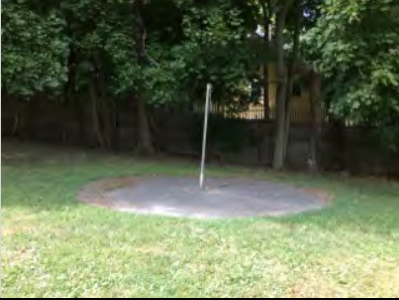
Court is not connected to an accessible route	-	Provide an accessible route to the court. (Cost estimate for 84 ft long 4' wide stone dust route.)	1	2688	\$2688
Best Practice												
16	Main Playground Picnic Table	Ext.

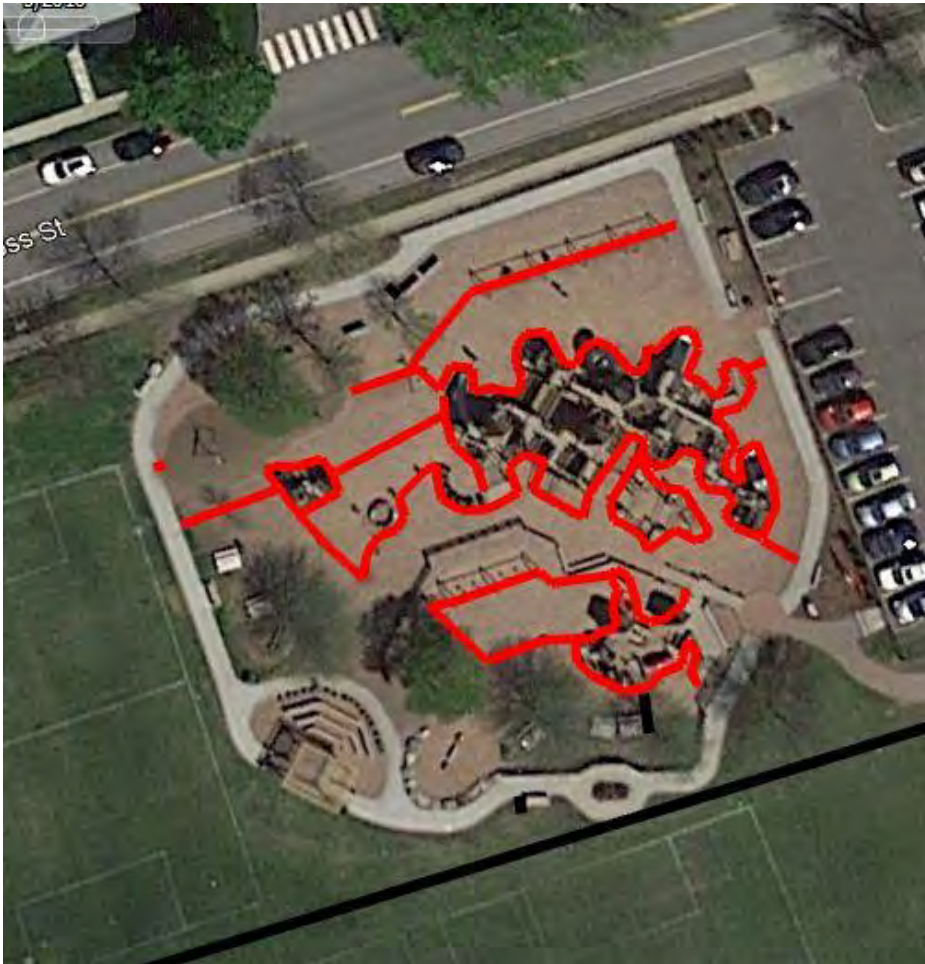
illustrating accessible routes to and around the play components within the playgrounds (in red).

Note: The ADA allows engineered wood fiber as an accessible surface when it is installed properly and maintained to be stable, firm and slip-resistant. Engineered wood fiber surfaces will require frequent maintenance to comply because of surface displacement due to weather, user activity and other factors.

The Massachusetts Architectural Access Board (MAAB) has long considered engineered wood fiber and wood chips as noncompliant and problematic materials. While it reserves the right to reevaluate this in the future, it is currently MAAB’s opinion that such material is not clearly compliant with the requirements of 521 CMR.

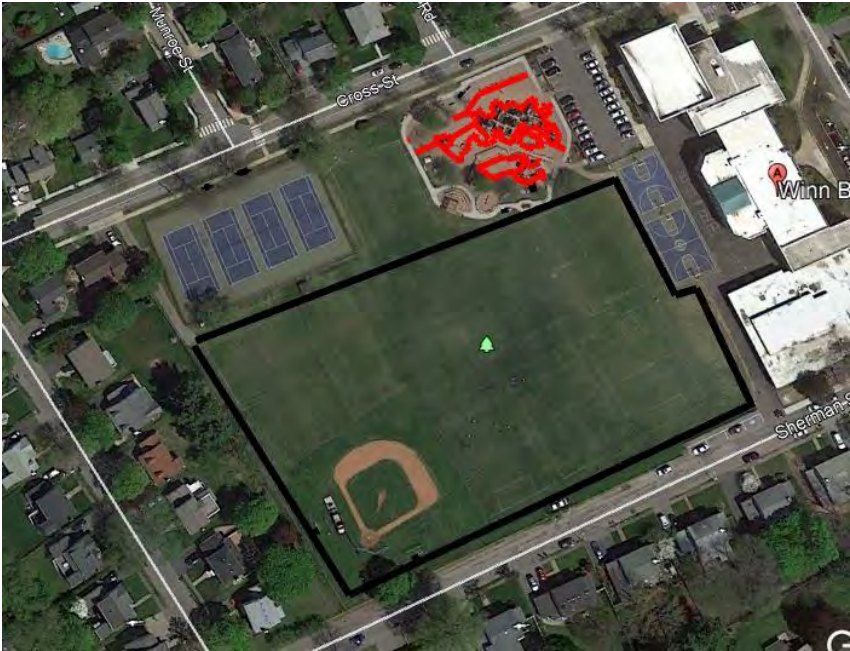
There is no accessible route connecting all areas of sport activity, including the baseball field, soccer fields, tennis courts and basketball courts. In addition, there is no accessible route to the team seating areas and there is a lack of clear floor space alongside the team benches in the baseball field. See the following diagram that illustrates a proposed route connecting all areas of sport activity in black:

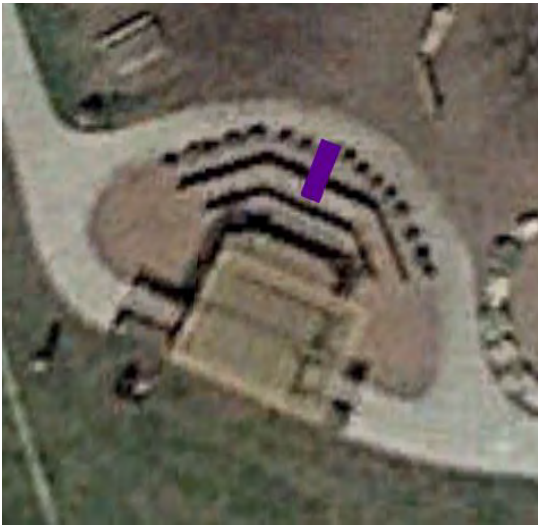
- Lack of a directional sign at the inaccessible entrance to the playground.
- Lack of maneuvering clearance with a slope of 1:50 (2%) max. at the Cross Street entrance to the park.
- Lack of an accessible route to one bench in each area.
- Lack of a wheelchair space in the seating area in front of the stage. See following diagram showing the recommended location of the wheelchair space in purple:

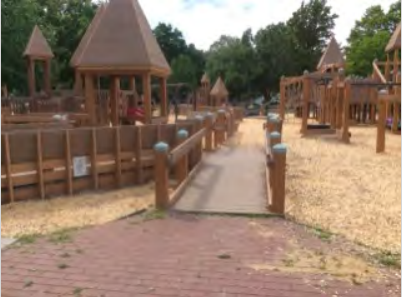
Level changes > 1/4"	1.25"	Alter change in level at the base of the ramp to be 1/4" high max.	1	256	\$256
2	Playground Walkway	Ext.		Exterior Access Route	Walkway

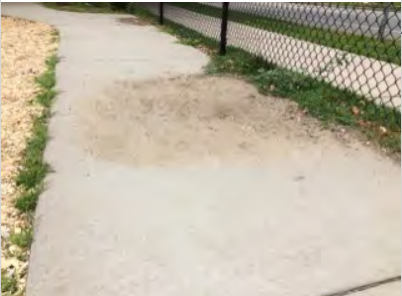
Route not maintained in operable working condition	-	Ensure the accessible route is maintained in operable working condition and kept clear of sand.	1	Labor	\$0
3	Playground Walkway	Ext.		Exterior Access Route	Walkway

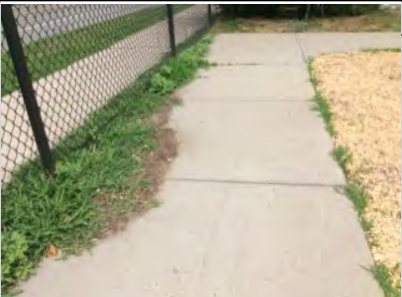
Route not maintained in operable working condition	-	Ensure the accessible route is maintained in operable working condition and kept clear.	1	Labor	\$0
4	Playground Entrance	Ext.		Exterior Access Route	Walkway

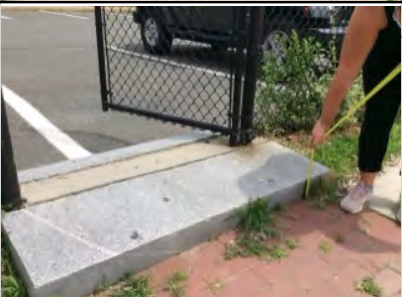
Accessible route not provided	4.5"	Provide an accessible route. (Cost estimate for a 6' long sloped concrete path with a level landing.)	1	384	\$384

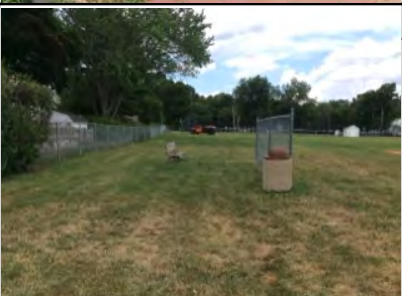
5	Baseball Diamond Trash Bin	Ext.		Exterior Access Route	Exterior

Accessible route not provided	-	Relocate the trash bin on the new accessible route.	1	Labor	\$0

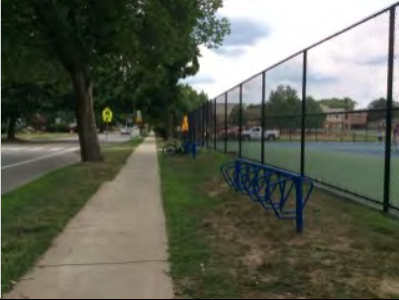
Accessible route not provided	-	Provide an accessible route to each bike rack. (Cost estimate based on 46 square ft. of stone dust.)	1	368	\$368
7	Playground Walkway Trash Bin	Ext.		Exterior Access Route	Exterior	 	Accessible route not provided	-	Relocate the trash bin to the edge of the path.	1	Labor	\$0
8	Playground Walkway Facing Basketball Court	Ext.		Exterior Access Route	Exterior

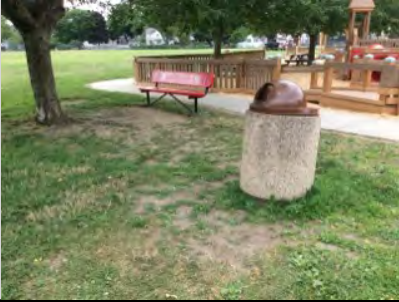
Accessible route not provided	-	Ensure an accessible route is provided to the trash bin. (Cost estimate for a 6' long 4' wide concrete route.)	1	384	\$384
Curb Ramp												
9	Parking Lot to Basketball Court	Ext.		Curb Ramp	N/A	 	Curb ramp not provided	6"	Provide a curb ramp at intersection. (Cost estimate for a concrete curb ramp.)	1	2800	\$2800

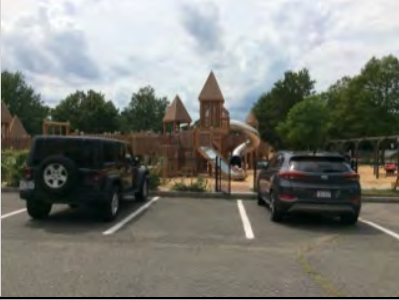
10	Parking Lot	Ext.		Curb Ramp	N/A

Curb ramp not provided	8"	Provide a curb ramp at intersection. (Cost estimate for a concrete curb ramp.)	1	2800	\$2800

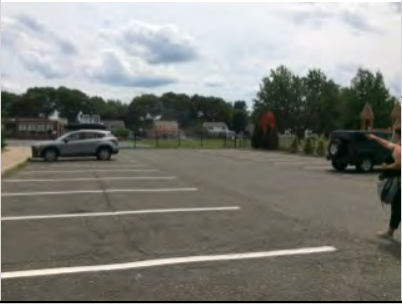
ID	Location	Floor	Room	Element	Type	Photo	Issues	Current Measure	Recommendations	Quantity	Price	Cost Estimation
Off-Street Parking Lot or Garage												
11	Parking Lot	Ext.		Off-Street Parking Lot or Garage	Visitor

Total # of parking Total # of designated accessible parking spaces Total # of designated van accessible spaces	28 0 0	Provide one car accessible parking space and one van accessible parking space.	2	800	\$1600
Entrance												
12	Stepped Playground Entrance	Ext.		Entrance	Secondary Entrance

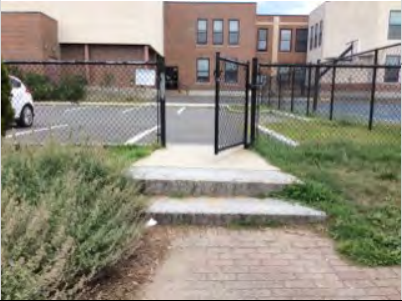
Entrance not on an accessible route Directional sign to accessible entrance not provided	- -	Provide a directional sign indicating the location of the nearest accessible entrance at the exterior of the gate. .	1	346	\$346
13	Cross Street Park Entrance	Ext.		Entrance	Secondary Entrance

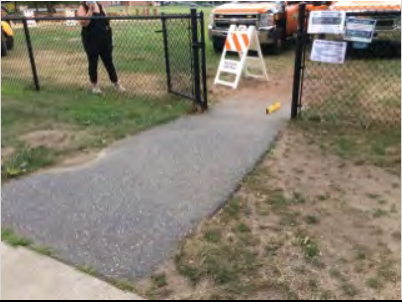
Maneuvering clearance at door > 1:50 (2.00%)	9.1%	Alter so that the slope in all directions is no greater than 1:50 (2.00%) at the gate.	1	360	\$360

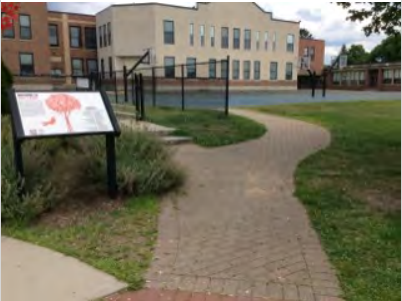
Signage not located on an accessible route	-	Provide an accessible route to the sign. (Cost estimate for a 6' long, 4' wide concrete route.)	1	384	\$384

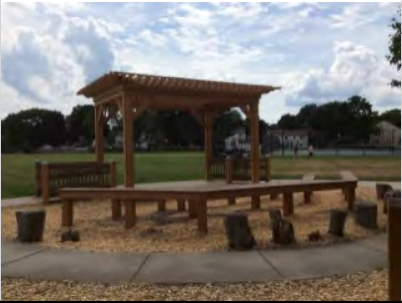
ID	Location	Floor	Room	Element	Type	Photo	Issues	Current Measure	Recommendations	Quantity	Price	Cost Estimation
Assembly Area												
15	Stage	Ext.		Assembly Area	N/A

Minimum # wheelchair spaces not provided Wheelchair spaces not on accessible route	- -	Provide one wheelchair accessible space with an accessible route to it. (Recommended location would be in the center of the back row.)	1	300	\$300
Picnic Tables												
16	Playground Walkway on the Northeast Side	Ext.		Picnic Tables	N/A

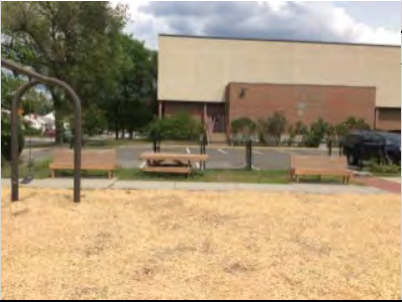
Toe or knee clearance at tables not provided Picnic table not on an accessible route	24" -	Provide at least 1 picnic table in this area has toe and knee clearance. Ensure that the picnic table is located on an accessible route.	1	1400	\$1400
17	Playground Walkway - Picnic Tables	Ext.		Picnic Tables	N/A

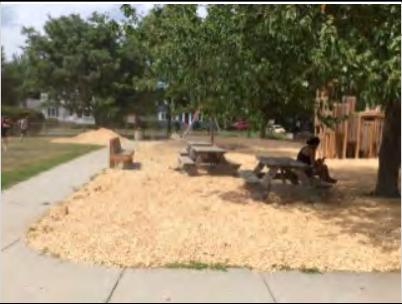
Picnic table not on an accessible route	-	Ensure that the accessible picnic table is connected to an accessible route. (Cost estimate for a 6' long, 4' wide concrete route.)	1	384	\$384

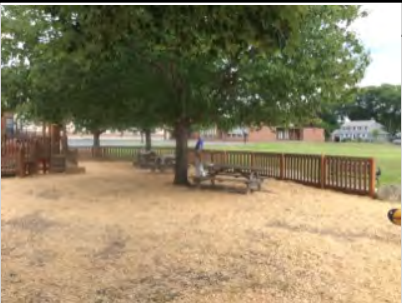
18	Tot Lot Picnic Area	Ext.		Picnic Tables	N/A

Picnic table not on an accessible route	-	Provide an accessible route to the accessible picnic table. (Cost estimate for a 10' long, 4' wide stone dust route.)	1	320	\$320
Exterior Benches												
19	Cross Street Sidewalk	Ext.		Exterior Benches	N/A

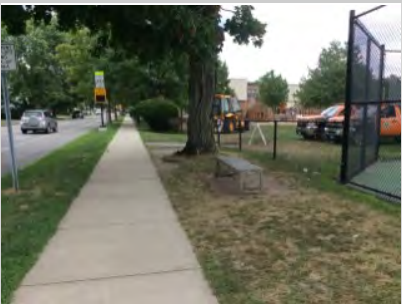
No accessible route to one bench in area	-	Provide an accessible route to the bench. (Cost estimate for 4' wide, 5' long stone dust route.)	1	160	\$160

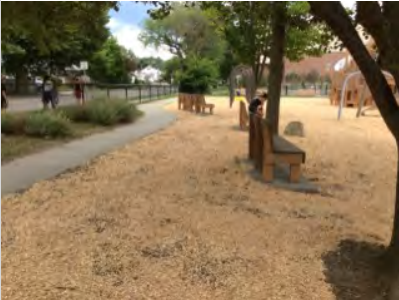
ID	Location	Floor	Room	Element	Type	Photo	Issues	Current Measure	Recommendations	Quantity	Price	Cost Estimation
20	Playground Walkway on the Northwest Side	Ext.		Exterior Benches	N/A

No accessible route to one bench in area	-	Provide an accessible route to one bench in this area. (Cost estimate for a 4' wide, 4' long asphalt route.)	1	160	\$160
21	Playground Walkway South Side - Bench Facing Field	Ext.		Exterior Benches	N/A

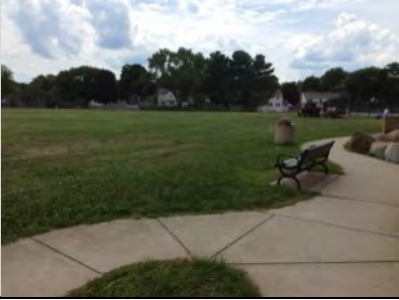
No accessible route to one bench in area	-	Provide an accessible route to one bench in this area. (Cost estimate for a 4' wide, 4' long stone dust route.)	1	128	\$128
22	Playground Walkway, Bench Facing Basketball Court	Ext.		Exterior Benches	N/A

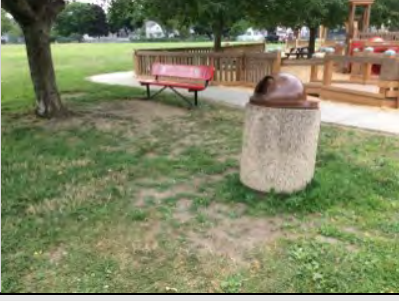
No accessible route to one bench in area	-	Provide an accessible route to the bench in this area. (Cost estimate for a 4' wide, 4' long stone dust route.)	1	128	\$128
Play and Sport Areas												
Play Areas

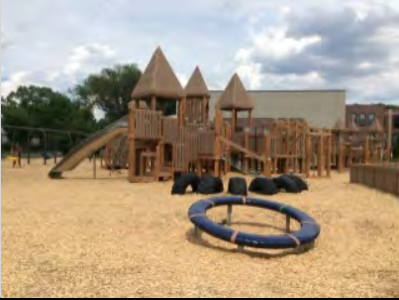
23	Playground	Ext.		Play Areas

Accessible route not provided to play components	-	Provide a compliant impact-attenuating surface to and around the play components. (Cost estimate for 4,070 sq. ft. of poured in place rubber surface.)	1	56980	\$56980
24	Tot Lot	Ext.		Play Areas	N/A

Accessibility issues include a lack of an impact attenuating accessible route to the play components inside the boundary of the playgrounds. In addition, play areas are not maintained in operable working condition due to wood chips that have infilled part of the accessible walkway. See the following diagram

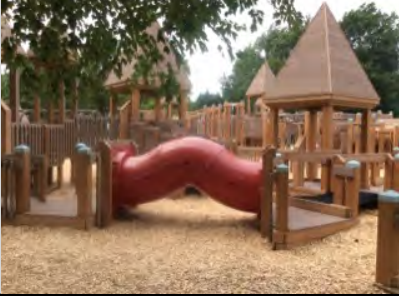
Accessible route not provided to play components	-	Provide a compliant impact-attenuating surface to and around the play components. Ensure that one bench in this playground is located on an accessible route. (Cost estimate for 1,284 sq. ft. of poured in place rubber surface.)	1	17976	\$17976

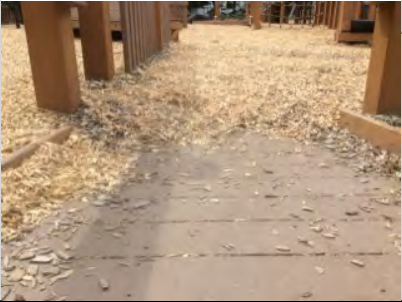
ID	Location	Floor	Room	Element	Type	Photo	Issues	Current Measure	Recommendations	Quantity	Price	Cost Estimation
25	Tot Lot Ramp	Ext.		Play Areas	N/A

Play areas not maintained in operable working condition	-	Ensure play area is maintained in operable working condition.	1	Labor	\$0
Field												
26	Baseball Diamond	Ext.		Field	Baseball

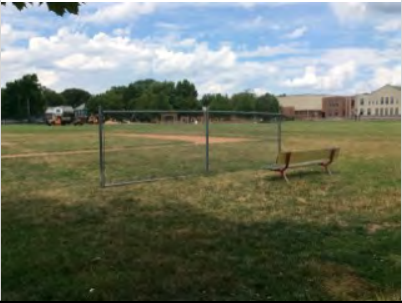
Accessible spaces not provided at team seating	-	Provide a 36" x 48" clear floor space at both team seating areas and a route to each team seating bench from the new accessible route around the park. (Cost estimate for 4' wide, 16' long stone dust routes.)	1	512	\$512
27	Soccer and Baseball Fields	Ext.		Field

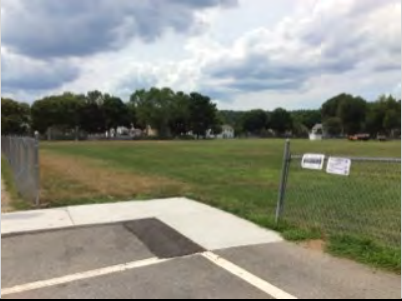
No accessible route to all areas of sport activity	-	Install an accessible route connecting all areas of sport activity, including routes between the soccer fields, baseball field, tennis courts and basketball court. (Cost estimate for 4' wide 1,515' long stone dust route.)	1	48480	\$48480

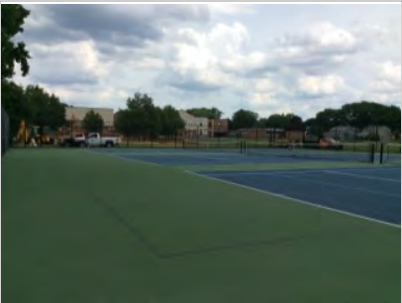
Best Practice												
28	Tennis Courts	Ext.

-	Recommend providing benches at tennis courts.	1	-	\$0
29	Stage	Ext.

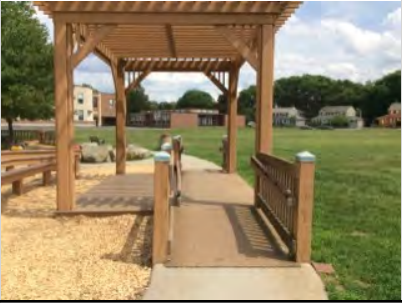
-	As the rise to the stage is less than 6", handrails are not required, but for greater access consider providing circular handrails located between 34"-38" high and between 18"- 20" high with 12" extensions at the top and bottom of the ramp run.	1	-	\$0

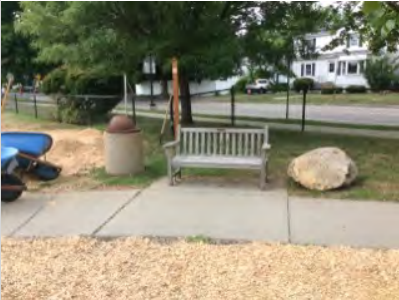
ID	Location	Floor	Room	Element	Type	Photo	Issues	Current Measure	Recommendations	Quantity	Price	Cost Estimation
30	Playground Walkway Bench	Ext.

-	Recommend providing clear floor space of 36" wide minimum by 48" deep alongside one bench so that a wheelchair user can sit alongside someone sitting on the bench.	1	-	\$0
31	Playground Walkway - Picnic Tables	Ext.

- Recommend providing clear floor space of 36" wide minimum by 48" deep alongside one bench so that a wheelchair user can sit alongside someone sitting on the bench. See the following diagram:

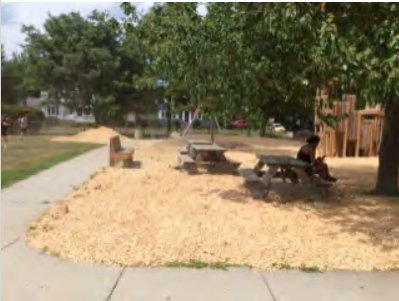
-	Recommend providing a 48" wide min. stable, firm and slip resistant surface under and around accessible picnic tables.	1	-	\$0
32	Tot Lot Ramp	Ext.

- Recommend providing benches at tennis courts.
- As the rise to the stage is less than 6", handrails are not required, but for greater access consider providing circular handrails located between 34" - 38" high and between 18" - 20" high with 12" extensions at the top and bottom of the ramp run.
- Recommend providing a 48" wide min. stable, firm and slip resistant surface under and around accessible picnic tables. See the following diagram:

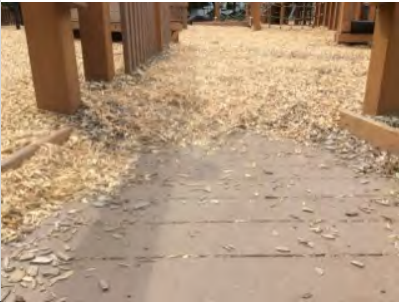
-	IHCD strongly recommends exploring the possibility of an alternative surface to engineered wood fiber (EWF). When used in combination with other surfaces required for accessible routes to play components in Massachusetts, it will present a challenge to prevent level changes at the transition points between EWF and other surfaces, and to keep the accessible routes clear of EWF.	1	-	\$0
