RECREATIONAL FACILITIES INVENTORY

TOWN OF BELMONT | JUNE 30, 2022

ACTIVITAS
landscape architecture | civil engineering

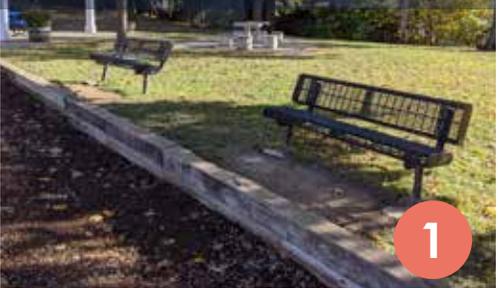
SITE BENCHES REQUIRE PAD AND ADA ACCESS

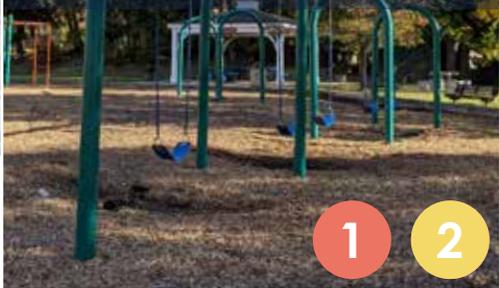
MULCH COMPACTION BENEATH SWINGS, HIGH TRAFFIC AREAS

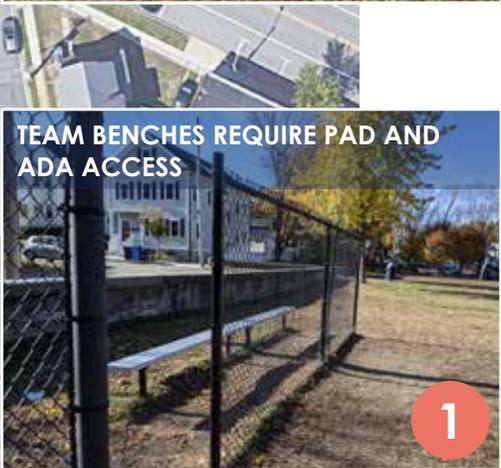
TEAM BENCHES REQUIRE PAD AND ADA ACCESS

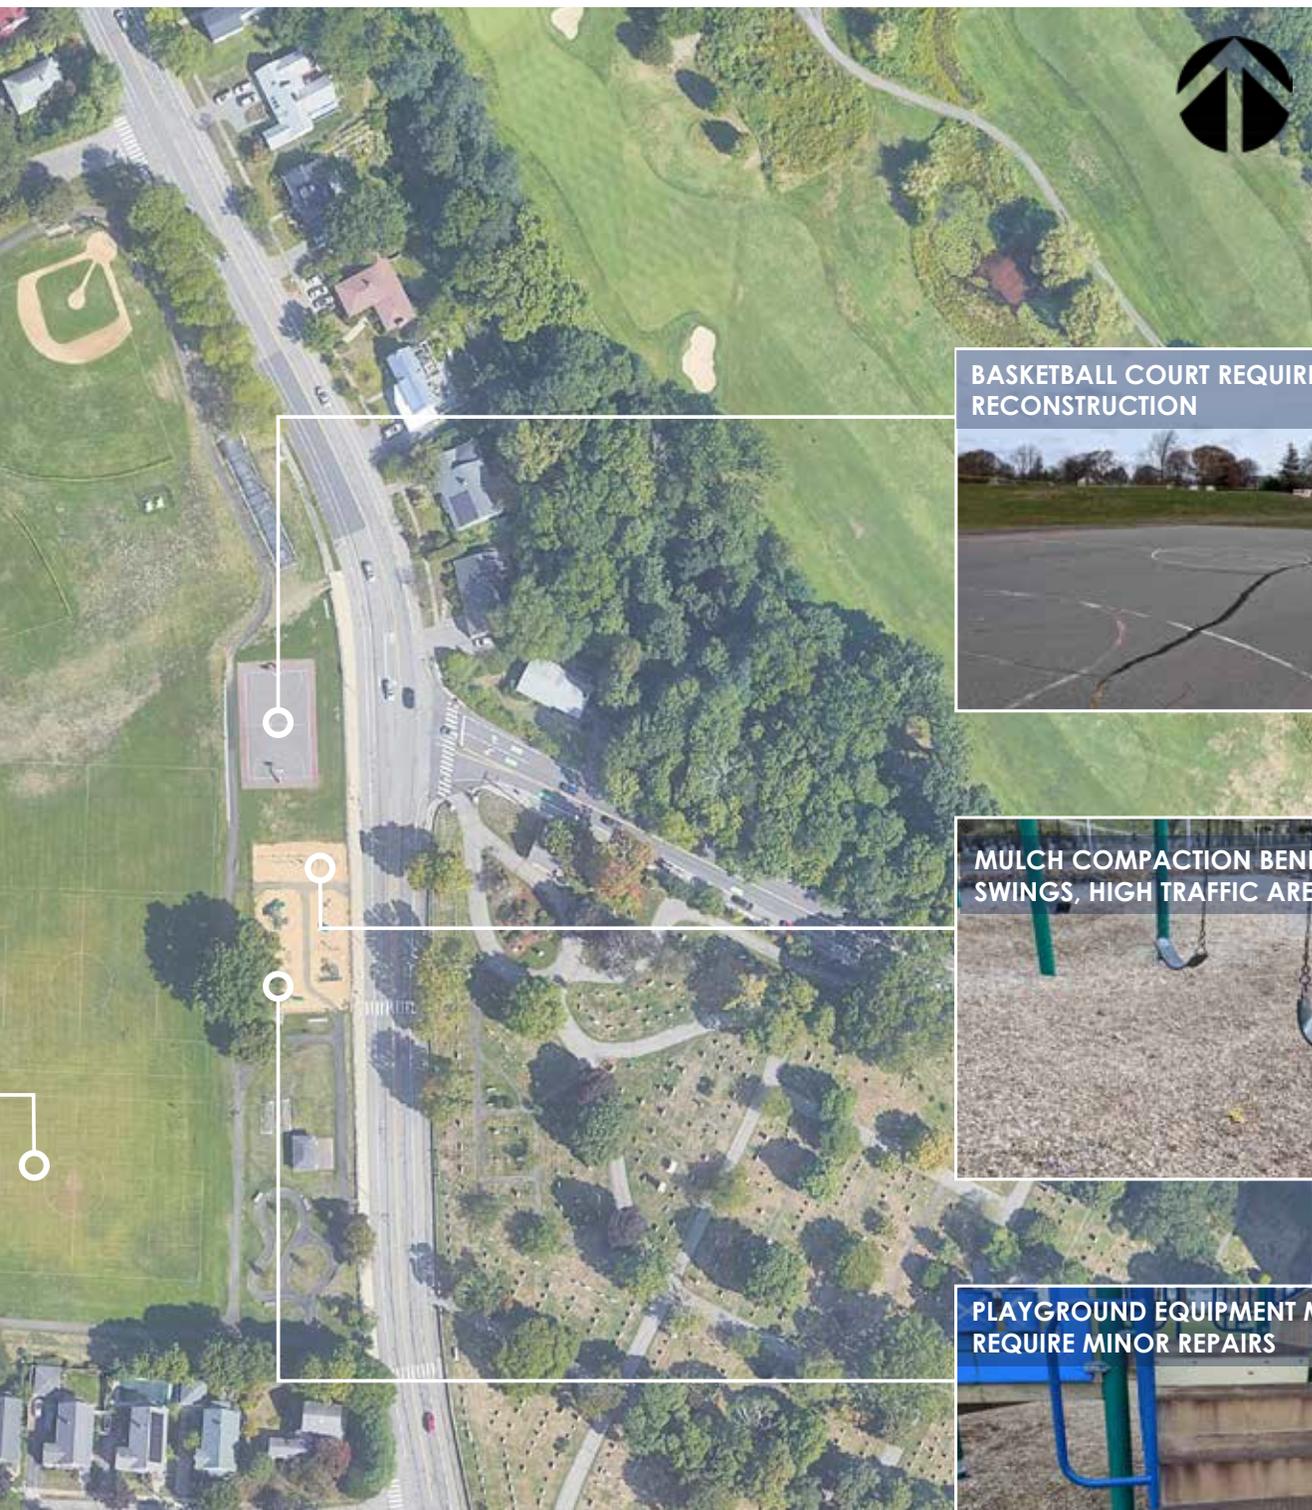
Asphalt basketball courts are cracking and need to be reconstructed.

BASKETBALL COURT REQUIRES RECONSTRUCTION

1	1 - 5 Years		
DESCRIPTION	COST RANGE		
Rebuild Basketball Court	\$175,000	-	\$225,000
Mulch Replenishment	\$12,500	-	\$16,000
Playground Swing Repairs	\$5,000	-	\$6,500
Fence Improvement	\$55,000	-	\$75,000
TOTAL	\$247,500	-	\$322,500

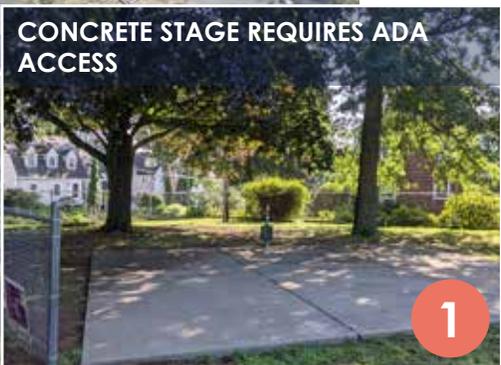
CONCRETE STAGE REQUIRES ADA ACCESS

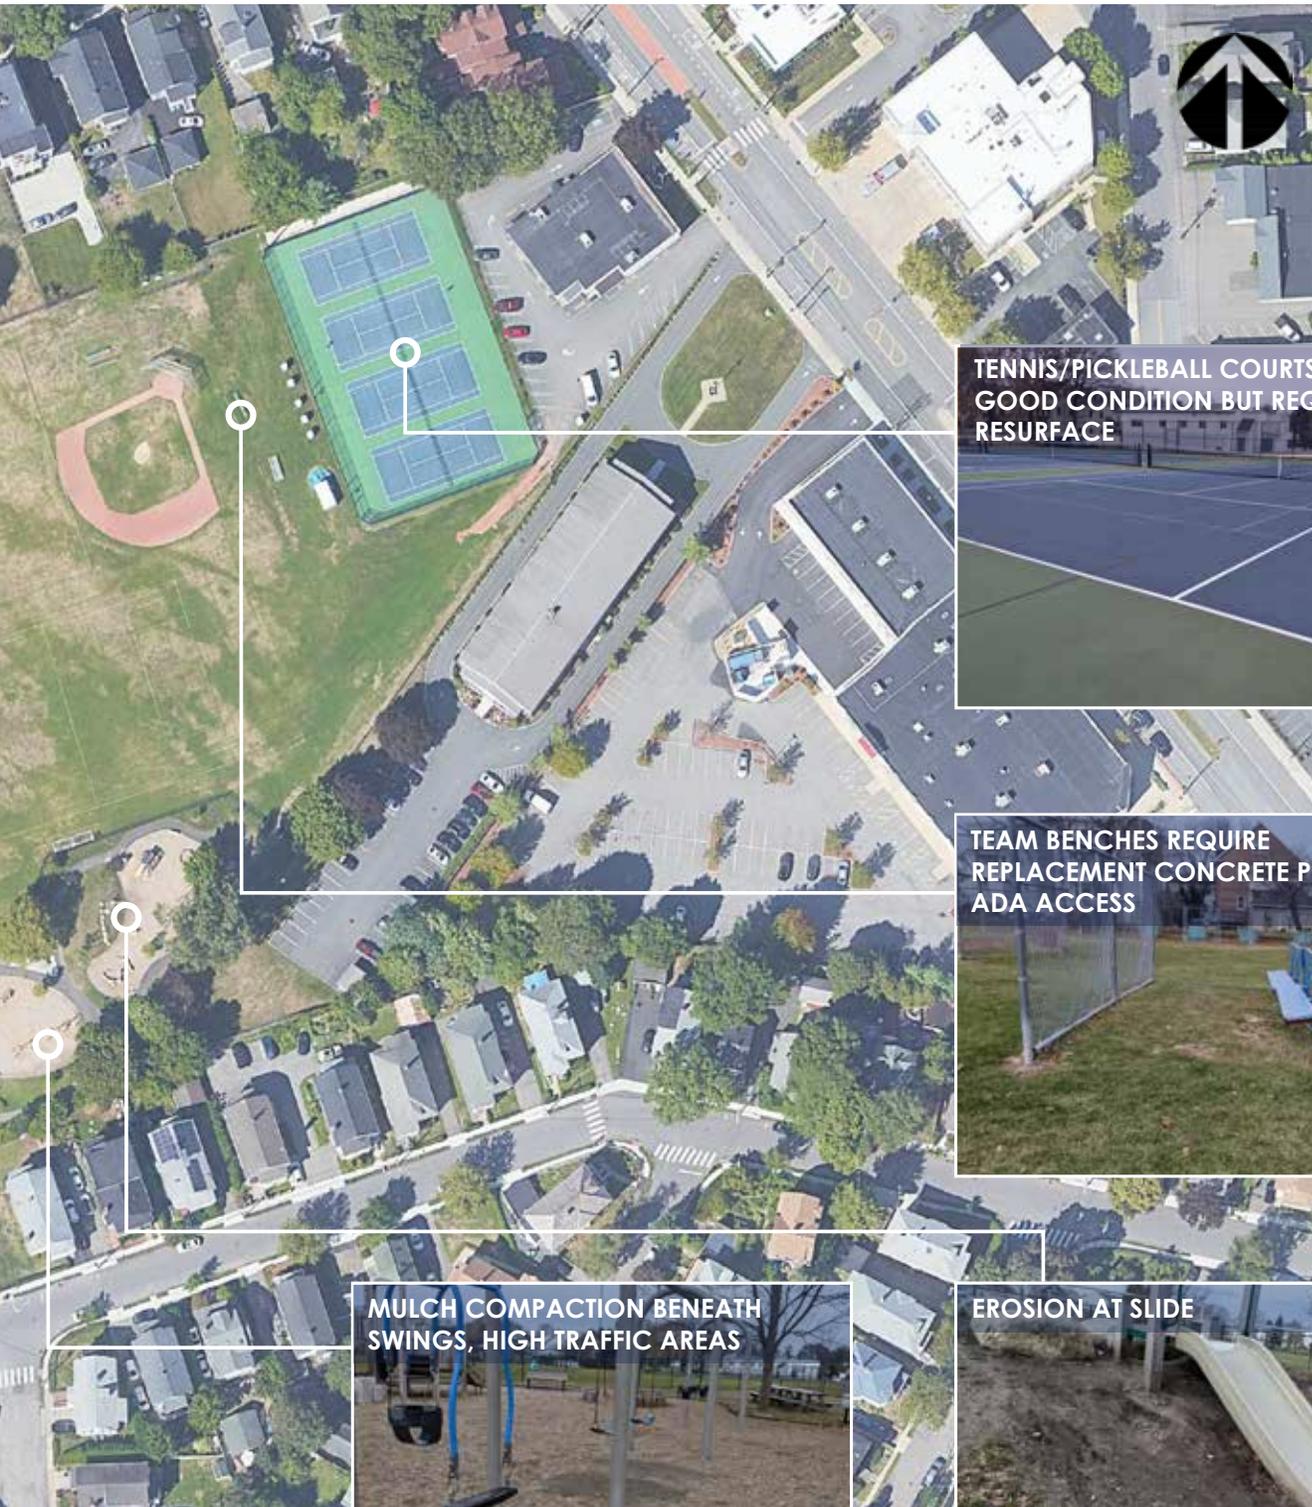
TENNIS/PICKLEBALL COURTS IN GOOD CONDITION BUT REQUIRE A RESURFACE

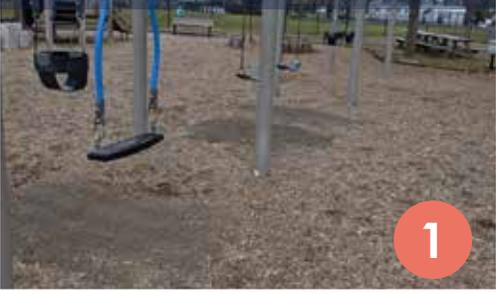
EROSION AT SLIDE

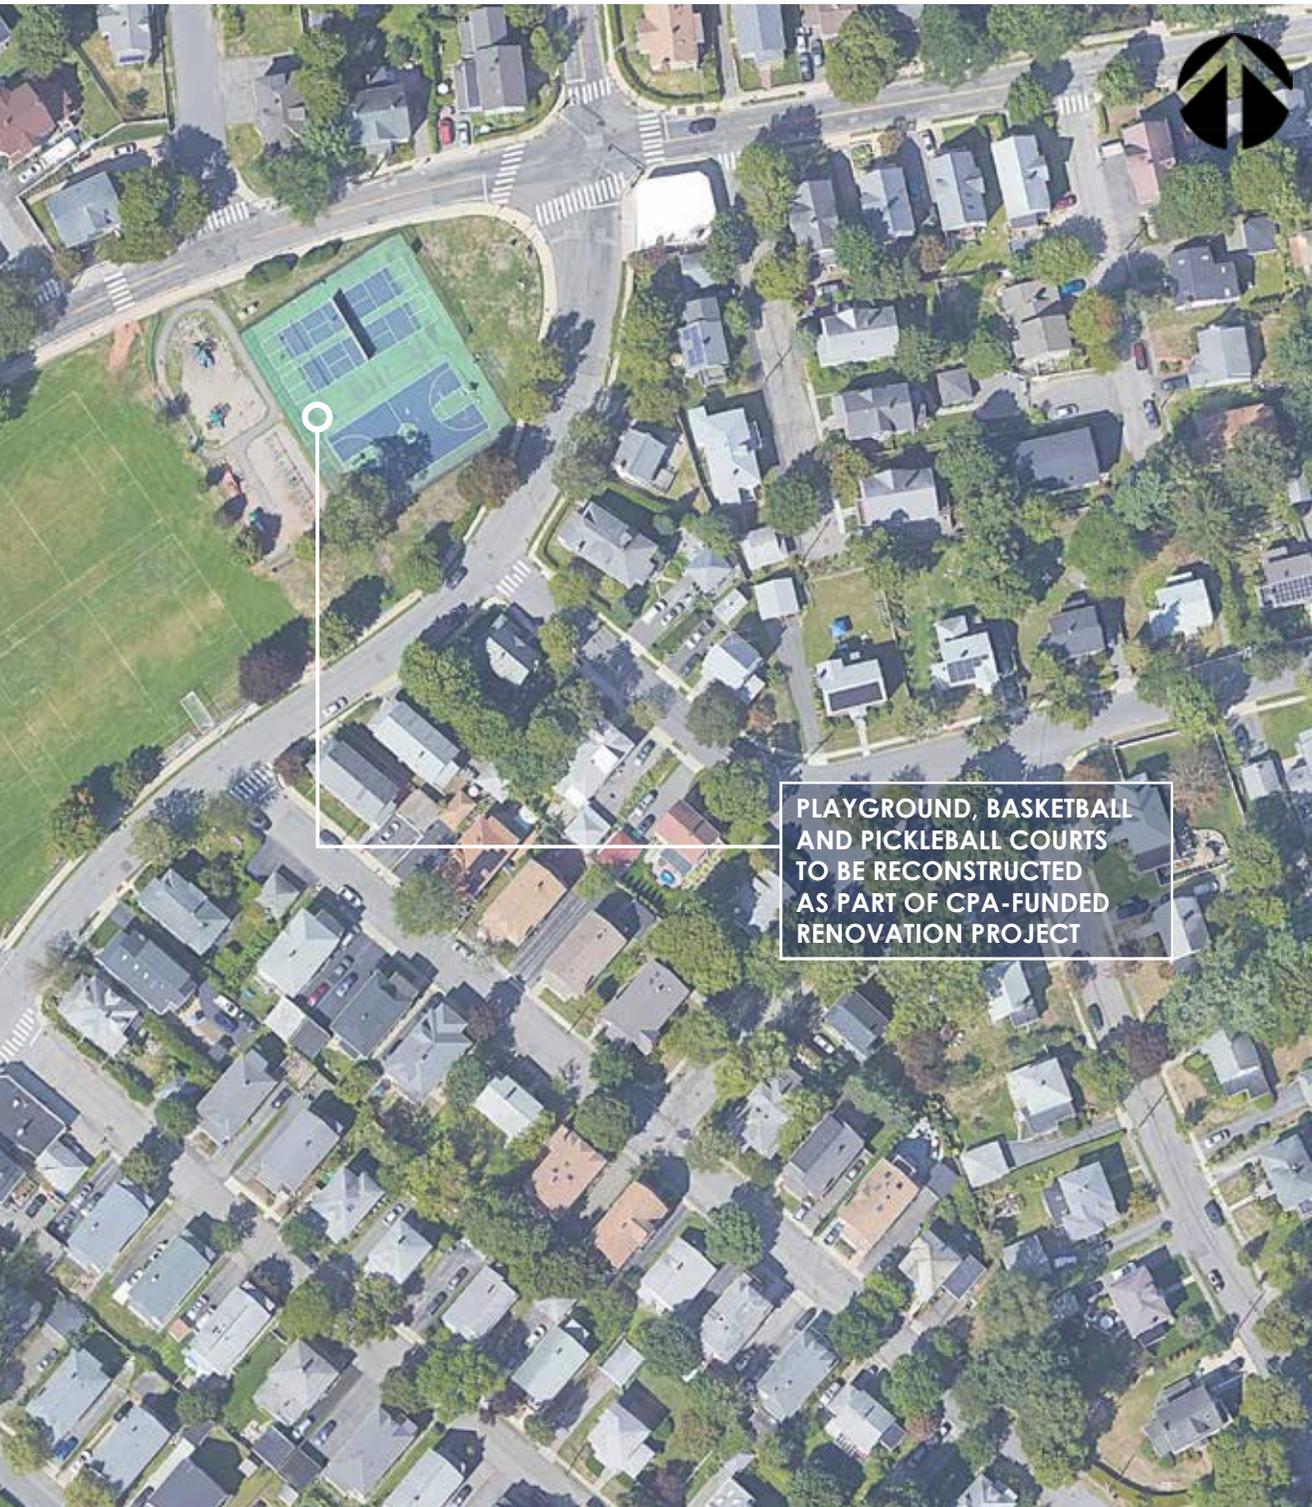
Cracking is evident in the asphalt at the basketball and pickleball courts. There are areas where cracks have extended beneath the surfacing and hollow patches can be felt underfoot. Large areas of surfacing is missing at center court.

PLAYGROUND, BASKETBALL
AND PICKLEBALL COURTS
TO BE RECONSTRUCTED
AS PART OF CPA-FUNDED
RENOVATION PROJECT

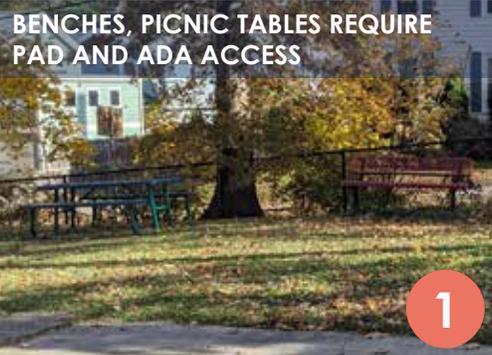
BENCHES, PICNIC TABLES REQUIRE PAD AND ADA ACCESS

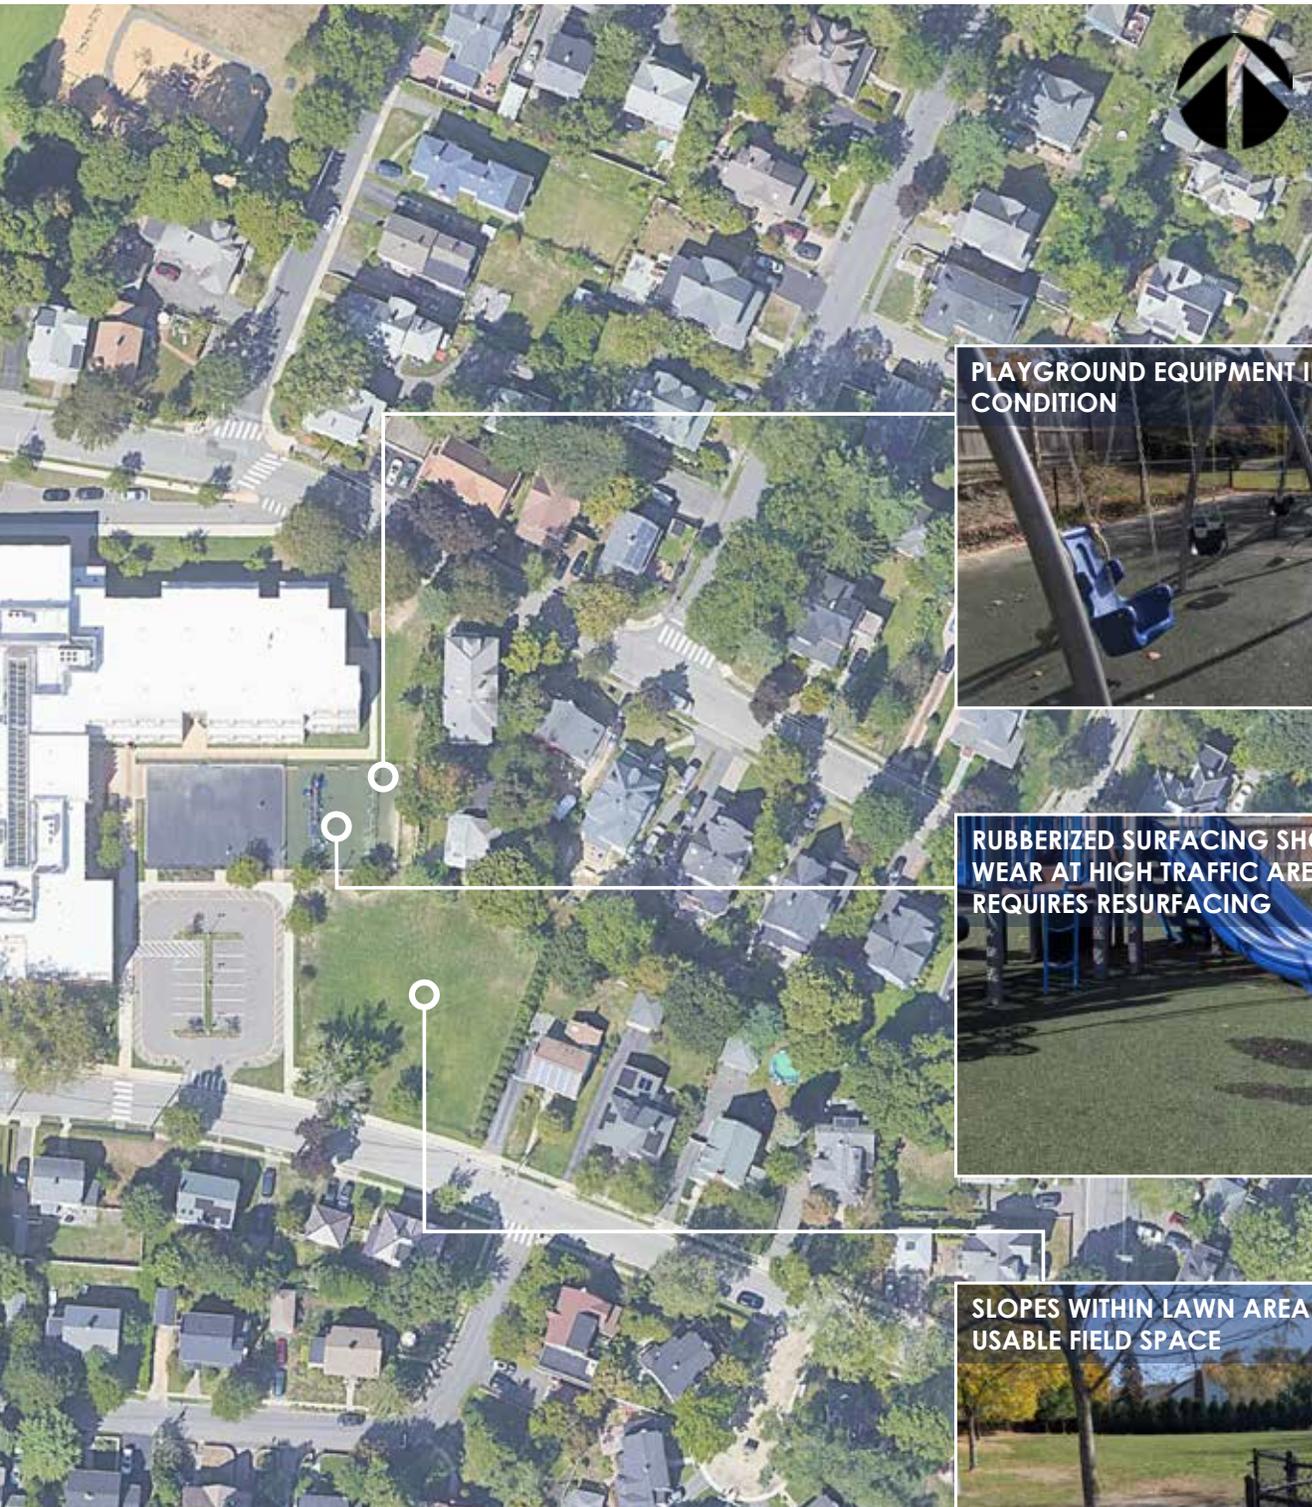
PLAYGROUND EQUIPMENT IN GOOD CONDITION

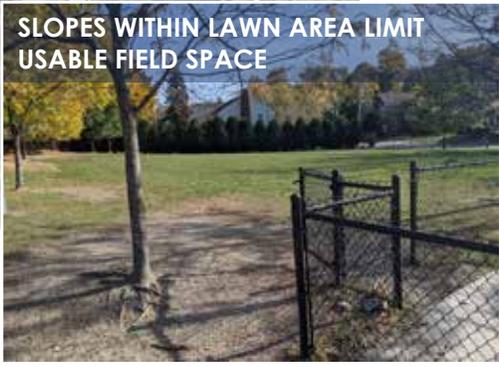
The natural grass field has significant uneven slopes within, with a high point beneath the existing large tree and a low point in the southeast corner with a catch basin, making recreational use impractical.

SLOPES WITHIN LAWN AREA LIMIT USABLE FIELD SPACE

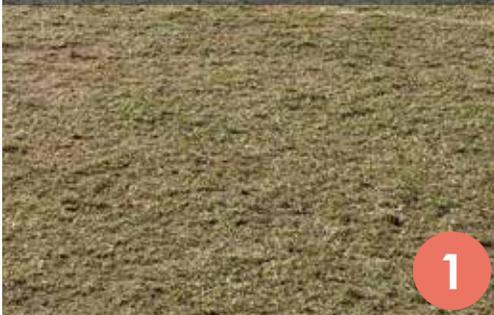
There are many areas of bare soil in the field from wear, particularly at high-traffic areas where goals have been positioned. Given the size of the facility, rotating fields to rest areas of grass should be possible both annually and throughout the course of a season.

FIELD SHOWS SIGNS OF WEAR
